BETH-EL TEMPLE FEASIBILITY STUDY DRAFT ISSUED 05.24.2013

PREPARED BY:
BROWNING DAY MULLINS DIERDORF ARCHITECTS

CONDITION ASSESSMENT.....35

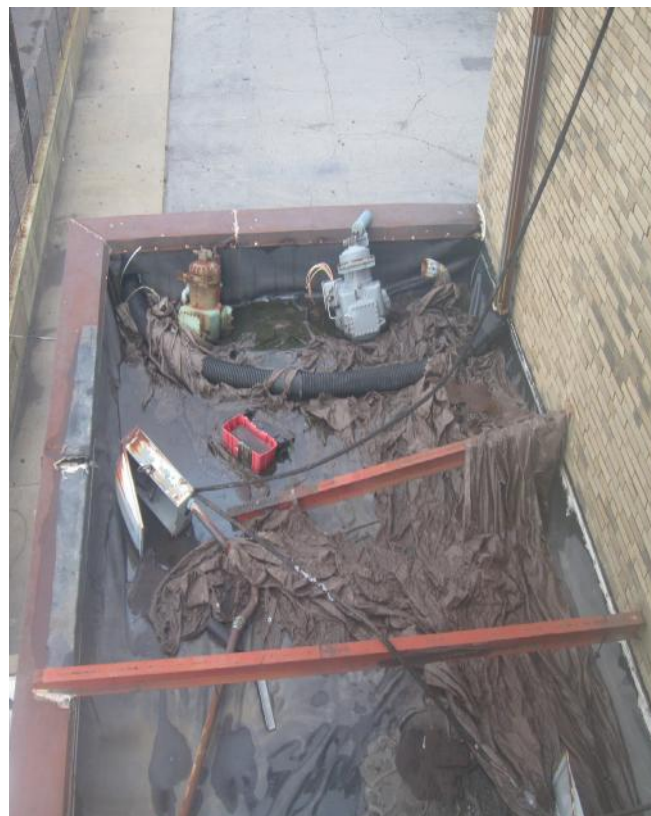
Area #3 roof covers the slightly lower roof at the southeast corner of the original portion of the building and covers 230 SF. This area has been reroofed with a single ply EPDM roof membrane and is in poor condition. This area has a significant amount of debris on it including a tarp, compressor, some metal scraps, etc. (See Photo 30). In addition to the debris, there are failed seams, membrane holes, roof penetrations and wall flashings.

Photo 30. Looking down on Area #3

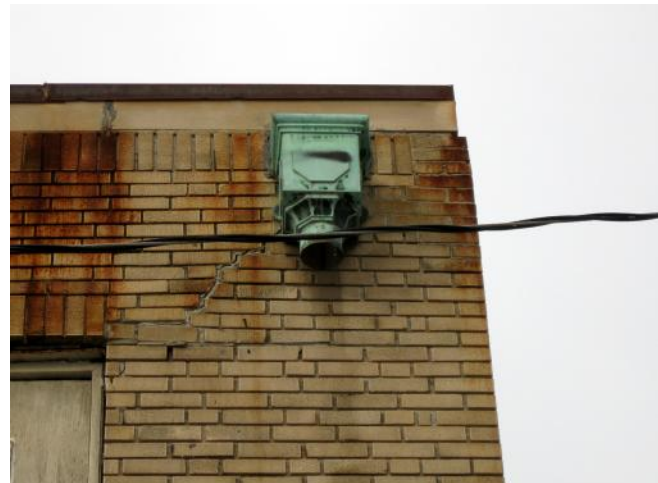
There are three (3) locations where downspouts are missing (See Photo 32). As water makes its way out

Photo 32. Rust staining, mortar deterioration, and missing downspout at southeast corner

of the conductor heads or gutters, it splashes down the face of the masonry. Over time, this becomes an issue as water eats away at the mortar. In the winter, ice can form and the freeze thaw cycle can do significant damage to both the brick and mortar.

The majority of the mortar deterioration at the brick is located near a downspout. It is estimated that approximately 20% of the entire surface area of the mortar is deteriorated to the point that it will need repointed.

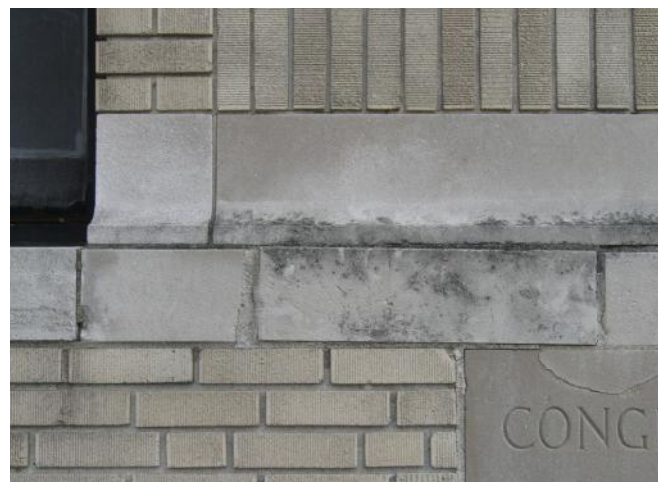
Photo 33. Mortar deterioration at limestone

The majority of the limestone on the building exhibits significant mortar deterioration. Likely, all of the limestone mortar joints will need repointed.

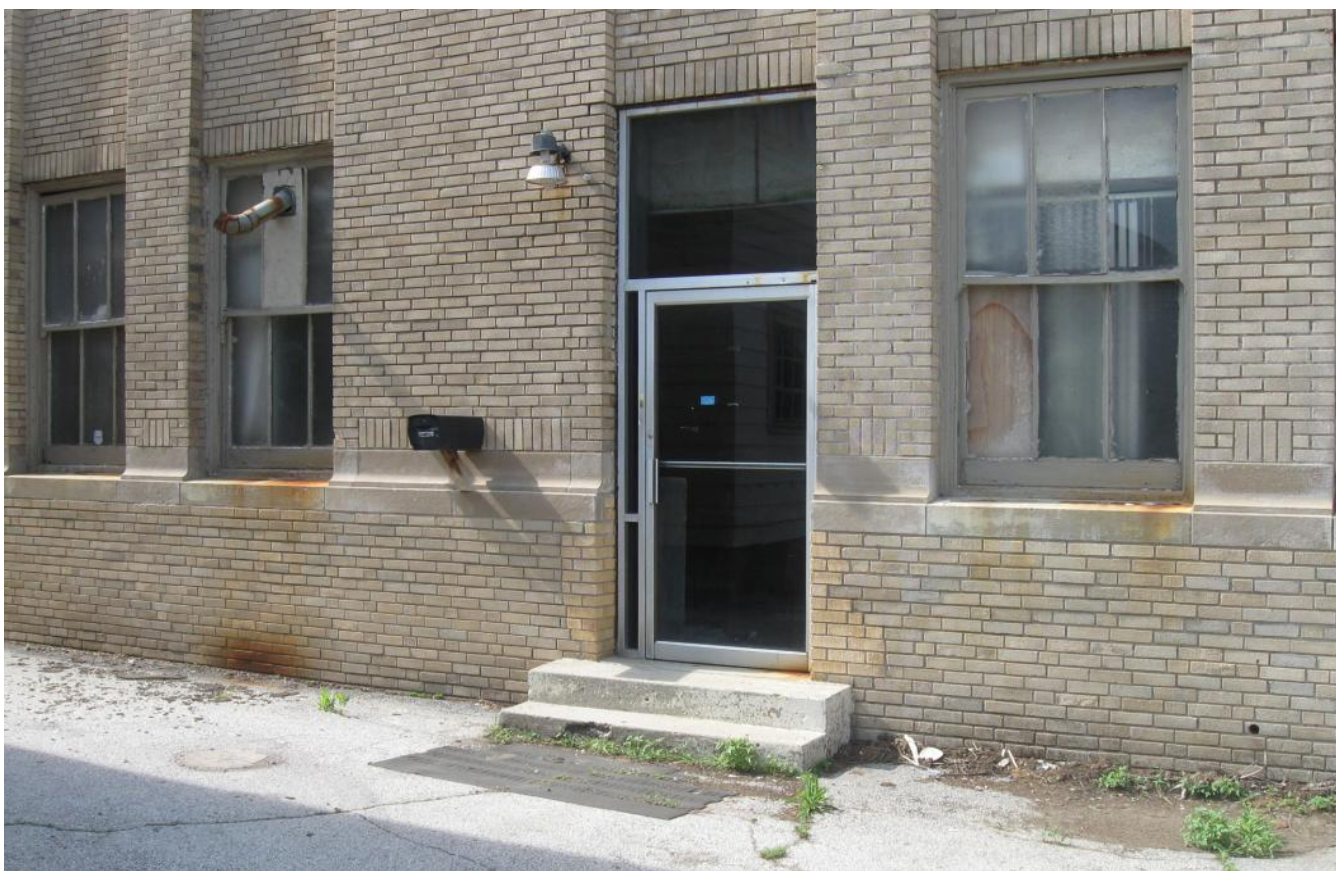
Photo 35. Typical first floor windows and south entrance door

The typical first floor windows on the north and south facades consists of a wood double hung unit with a three-over-three light configuration (See Photo 35 and 36). It measures 4'-4" x 7'-4". There are a total of eighteen (18) of this type of window. With the exception of one unit, they are all covered on the north elevation by the addition. From the interior, some of these units are still visible. The south elevation windows are all visible, although one of the units was converted into an entrance door. This is clear from looking at the brick at that location. The windows vary greatly in condition. Several of the windows on the south elevation are continually saturated from water infiltration that is making its way to the first floor from the leaks in the Area #1 roof above. These windows are exhibiting some rot and softening of the wood. Generally, all windows

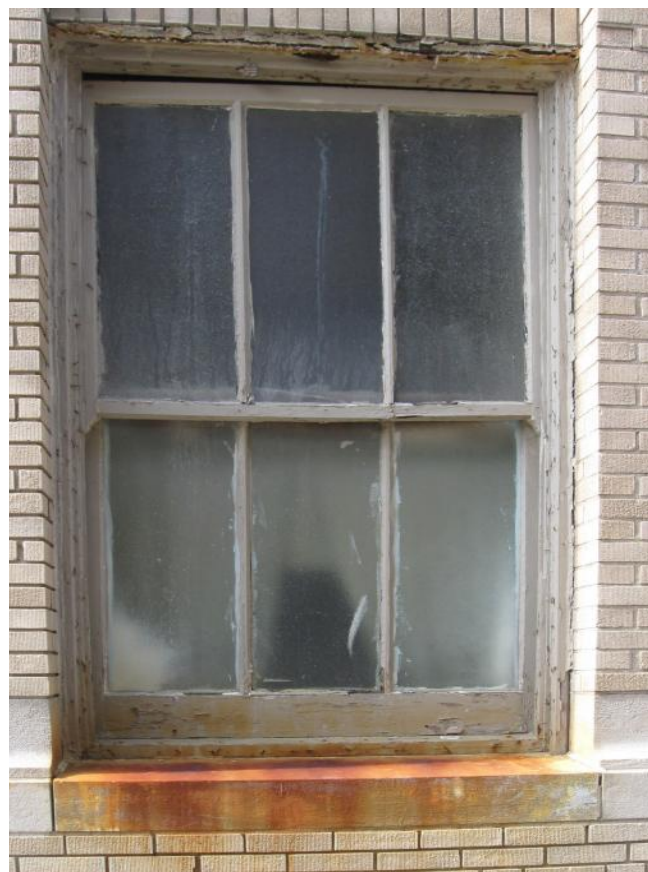
Photo 36. Typical first floor window

exhibit some deterioration due to water infiltration. Common issues among this window type are peeling paint, cracked window glazing, deteriorated glazing putty, and wood rot. Although these windows have some issues, it is not uncommon of windows of this age. They are original to the building and certainly can be restored.

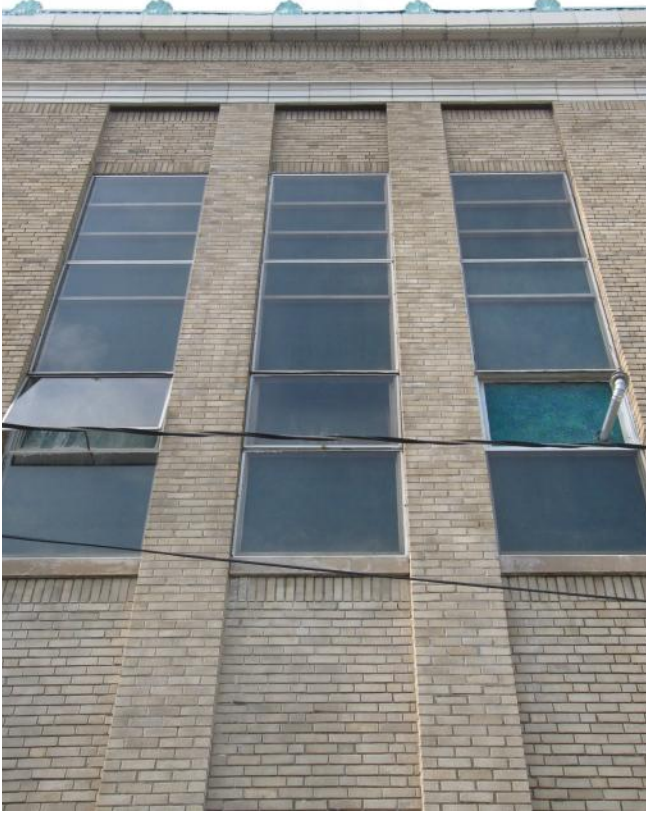
Photo 37. Second floor windows on south facade

There are eighteen (18) second floor sanctuary windows on the north and south facades (See Photo 37). These windows are aluminum framed windows divided into a six light configuration and measuring 4'4" wide by 16'-2" high. Some of the lights are operable. The glass consists of a translucent blue and white art glass. There is a storm window on the exterior. These windows are in poor condition. It is also clear that they are not original to the building, as a different light configuration is visible in the 1925 photograph.

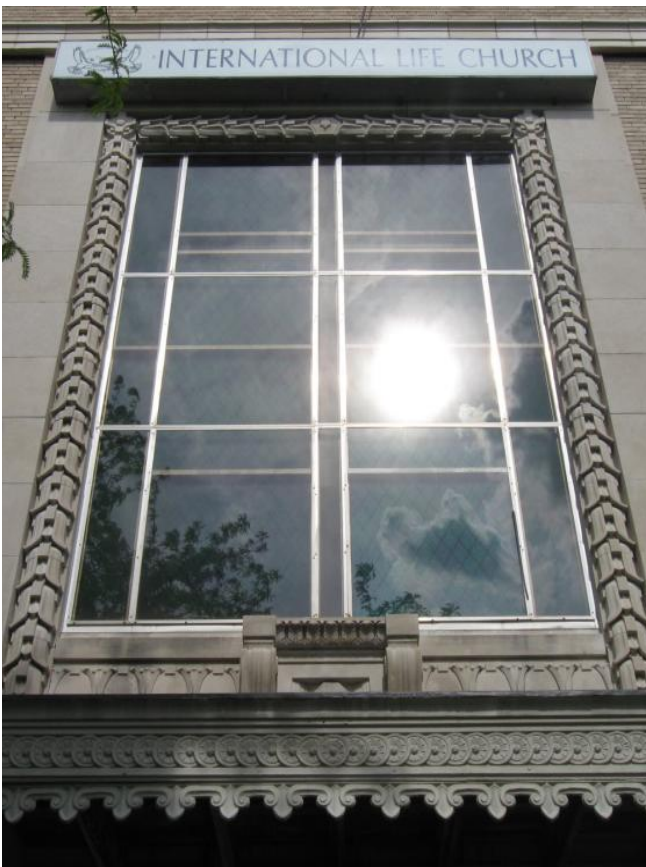
Photo 38. Second floor windows on west facade

A large aluminum framed window sits above the door at the west facade (See Photo 38). This window helps define the front entry and also provide natural light into the sanctuary. Like the other sanctuary windows, this window is aluminum and is not original to the building, as the light configuration in the 1925 clearly differs from the current configuration. This window also has a storm window on the exterior. This window is fair condition.

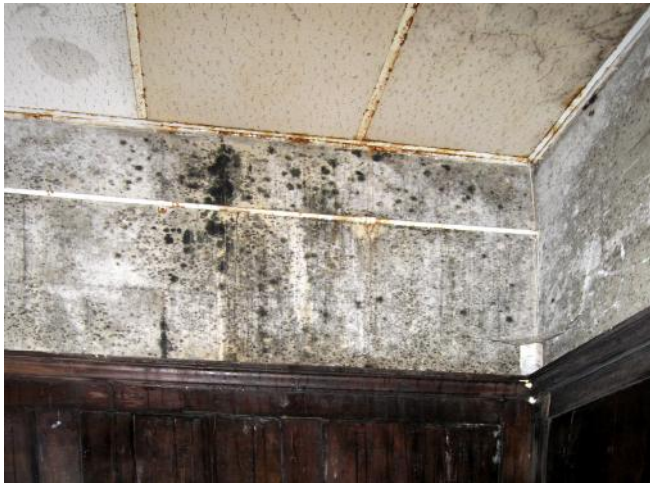
Photo 43. Mold growth on plaster at upper extent of lobby walls

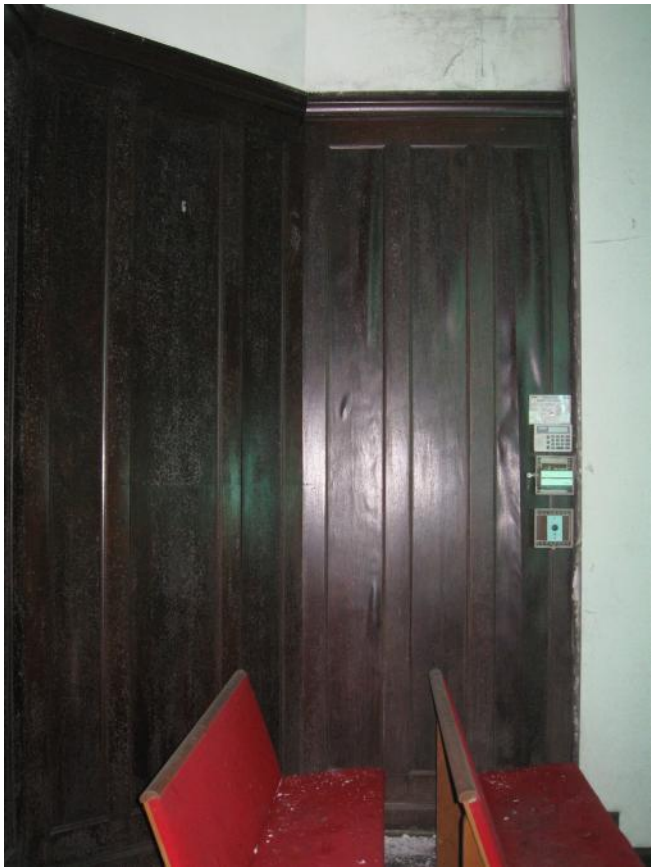
Photo 49. Warped veneer at wood paneling
