# BETH-EL TEMPLE FEASIBILITY STUDY DRAFT ISSUED 05.24.2013

PREPARED BY:  
BROWNING DAY MULLINS DIERDORF ARCHITECTS

# EXECUTIVE SUMMARY

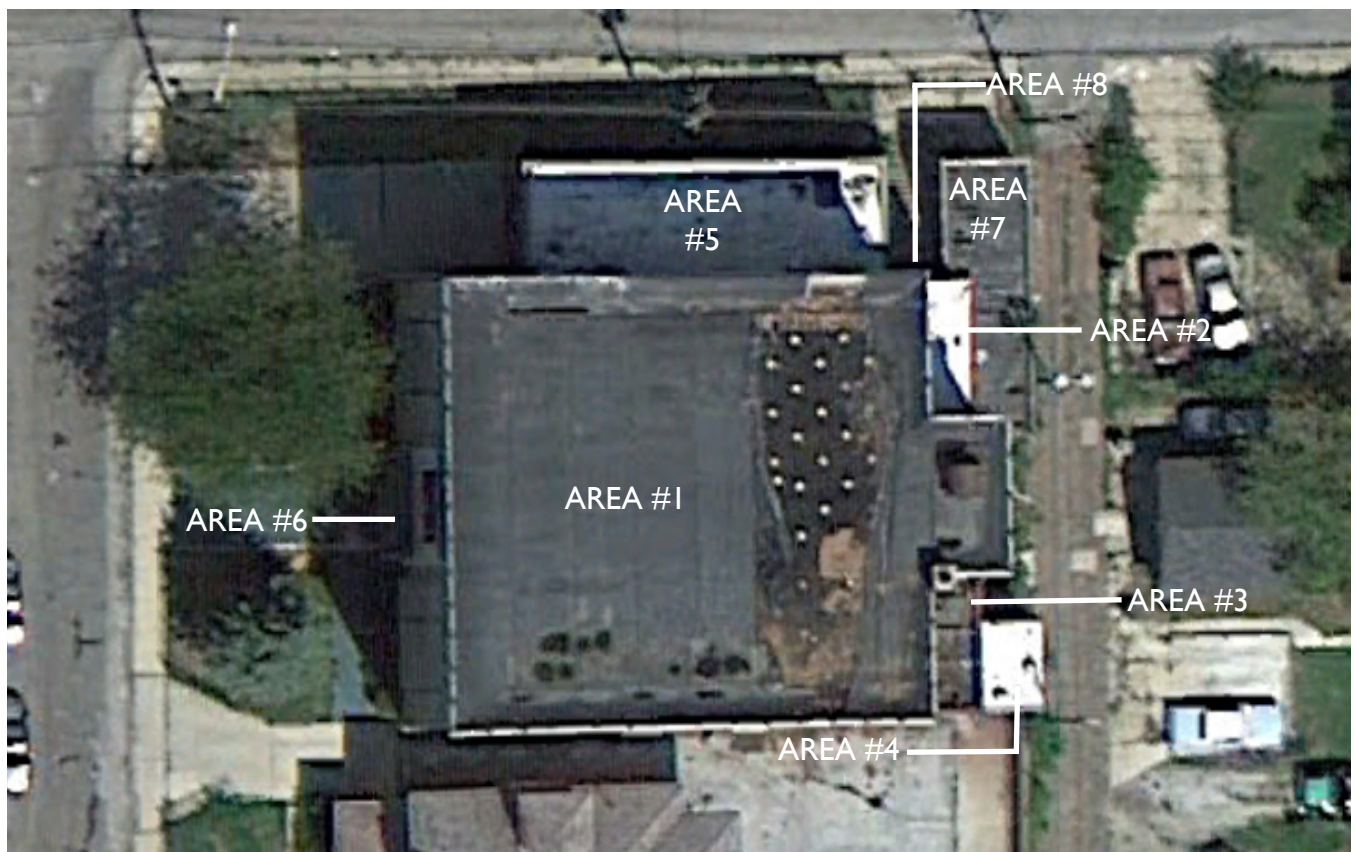
Area #1 is the main roof over the sanctuary and is the largest roof at 5480 SF. This roof is a single ply EPDM roof which was installed over a built up roof. The decking material is wood. The issue with this roof began with a seam failure and shrinkage at the perimeter of the roof causing it to tear away from the termination bar and exposing the underlying roofing and roof deck. This has occurred at both the north and south sides of the roof. At the time of Superior's report, they estimated that approximately 100 sf of roof area had been compromised. Although access to the roof was not available for the current study, based upon visual evidence of the plaster damage and water infiltration below in the sanctuary, as much as 3,000 sf of the 5,480 sf roof is compromised as of May 2013.

Photo 29. Satellite image of roof from Google Earth

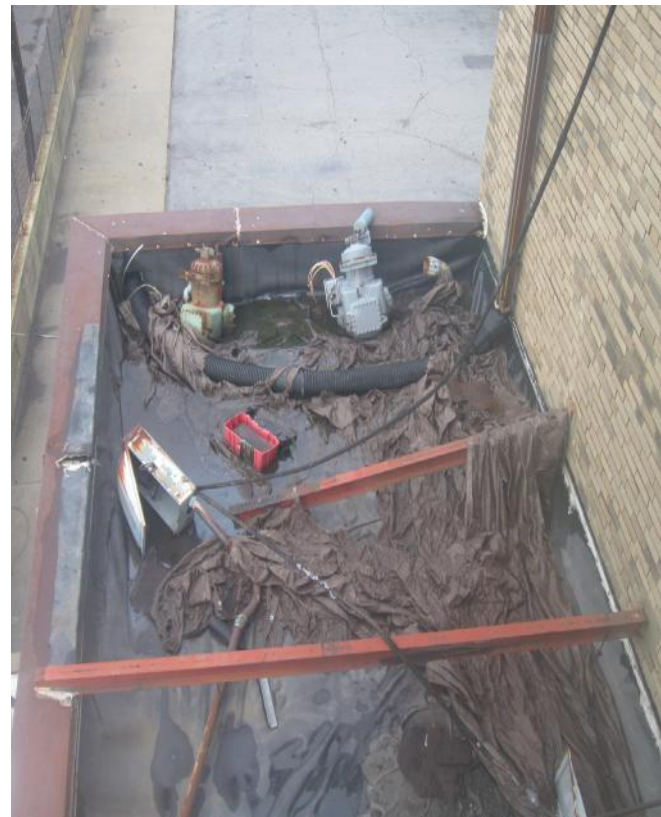
Area #3 roof covers the slightly lower roof at the southeast corner of the original portion of the building and covers 230 SF. This area has been reroofed with a single ply EPDM roof membrane and is in poor condition. This area has a significant amount of debris on it including a tarp, compressor, some metal scraps, etc. (See Photo 30). In addition to the debris, there are failed seams, membrane holes, roof penetrations and wall flashings.

Photo 30. Looking down on Area #3

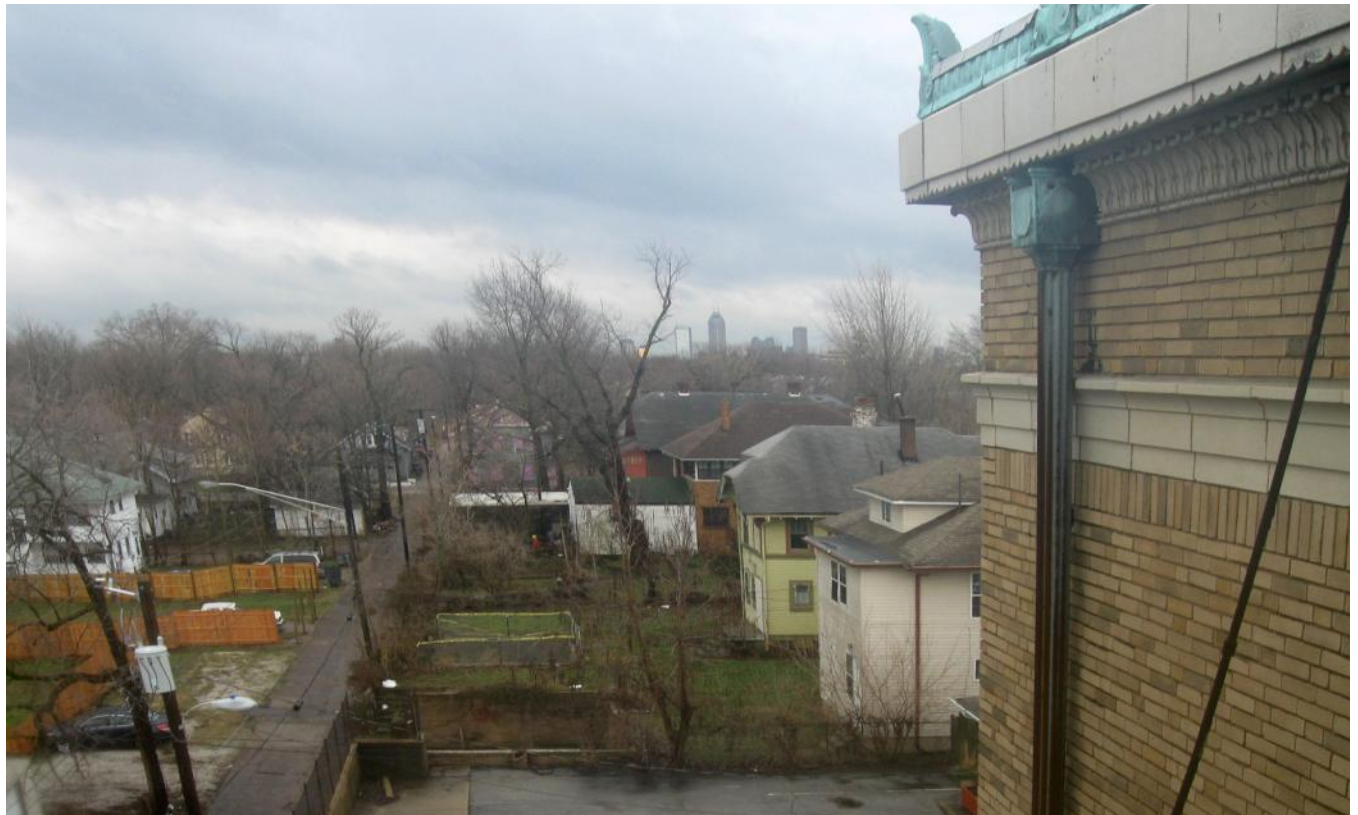
Photo 31. Detail of parapet, conductor head, and downspout

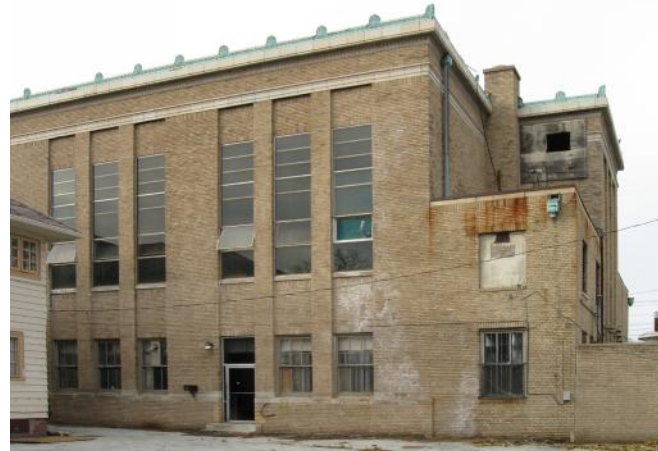
Because the roof has failed, water is making its way through the roof deck and into the interior of the building. This is saturating the walls. There is at least one location where efflorescence can be seen on the exterior brick (See Photo 31). Efflorescence is caused by water getting into the wall system and driving salts that are in the mortar to the surface of the brick. These salts form a powdery film at the locations where this is occurring.

**Photo 31. Efflorescence, rust stains, and mortar deterioration at southeast corner**

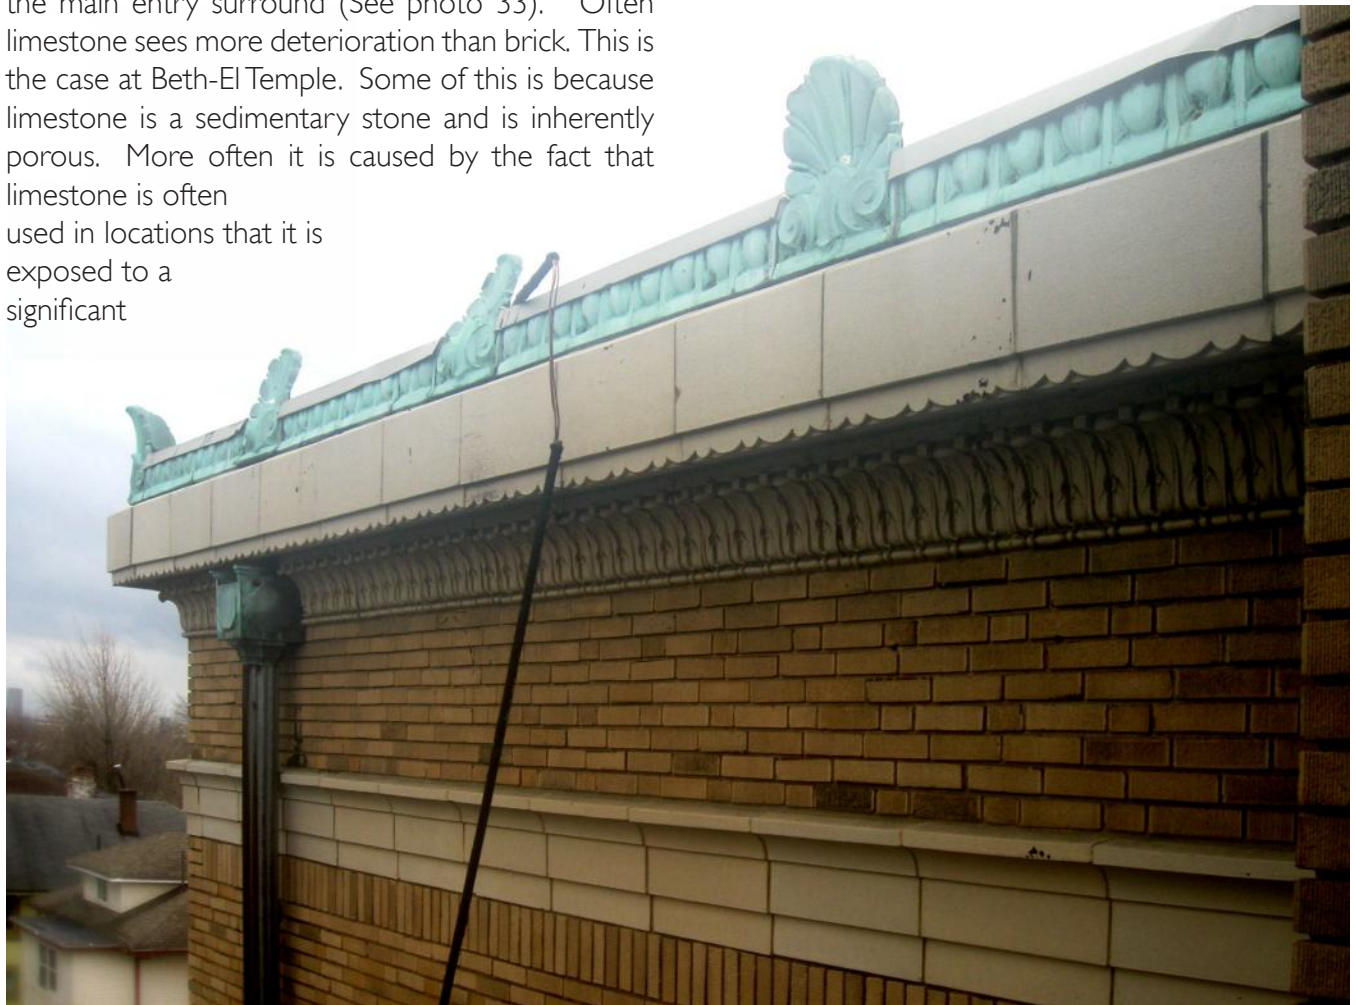
Terra cotta can have durability issues if it is not maintained. At least 15 of the acanthus leaf details at the cornice are missing. Several others are leaning and appear to be out of plane (See Photo 34). In total, 40 pieces of terra cotta were identified to be replaced.

Photo 34. Detail of terra cotta showing out of plane details

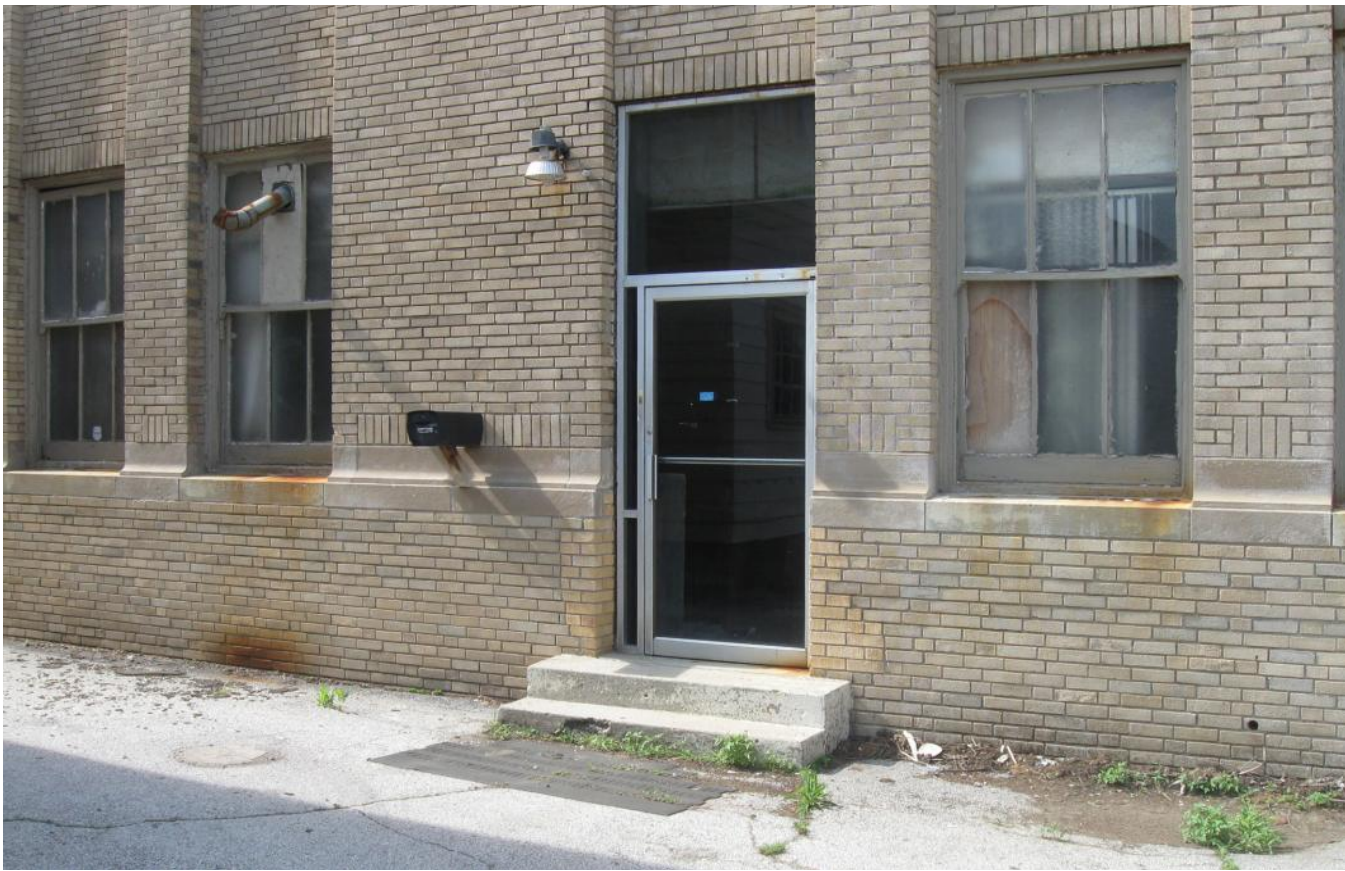
Photo 35. Typical first floor windows and south entrance door

The typical first floor windows on the north and south facades consists of a wood double hung unit with a three-over-three light configuration (See Photo 35 and 36). It measures 4'-4" x 7'-4". There are a total of eighteen (18) of this type of window. With the exception of one unit, they are all covered on the north elevation by the addition. From the interior, some of these units are still visible. The south elevation windows are all visible, although one of the units was converted into an entrance door. This is clear from looking at the brick at that location. The windows vary greatly in condition. Several of the windows on the south elevation are continually saturated from water infiltration that is making its way to the first floor from the leaks in the Area #1 roof above. These windows are exhibiting some rot and softening of the wood. Generally, all windows

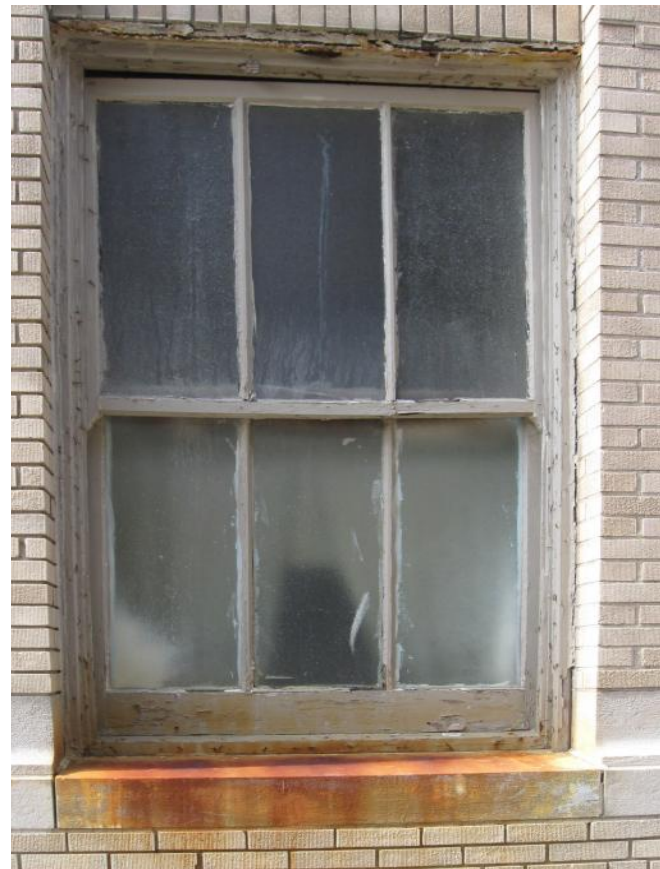
Photo 36. Typical first floor window

exhibit some deterioration due to water infiltration. Common issues among this window type are peeling paint, cracked window glazing, deteriorated glazing putty, and wood rot. Although these windows have some issues, it is not uncommon of windows of this age. They are original to the building and certainly can be restored.

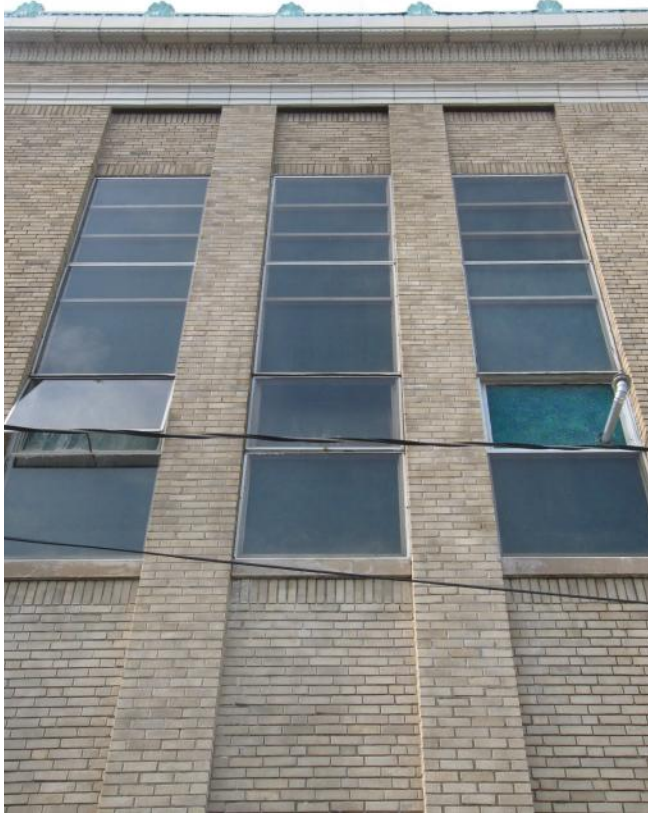
Photo 37. Second floor windows on south facade

There are eighteen (18) second floor sanctuary windows on the north and south facades (See Photo 37). These windows are aluminum framed windows divided into a six light configuration and measuring 4'4" wide by 16'-2" high. Some of the lights are operable. The glass consists of a translucent blue and white art glass. There is a storm window on the exterior. These windows are in poor condition. It is also clear that they are not original to the building, as a different light configuration is visible in the 1925 photograph.

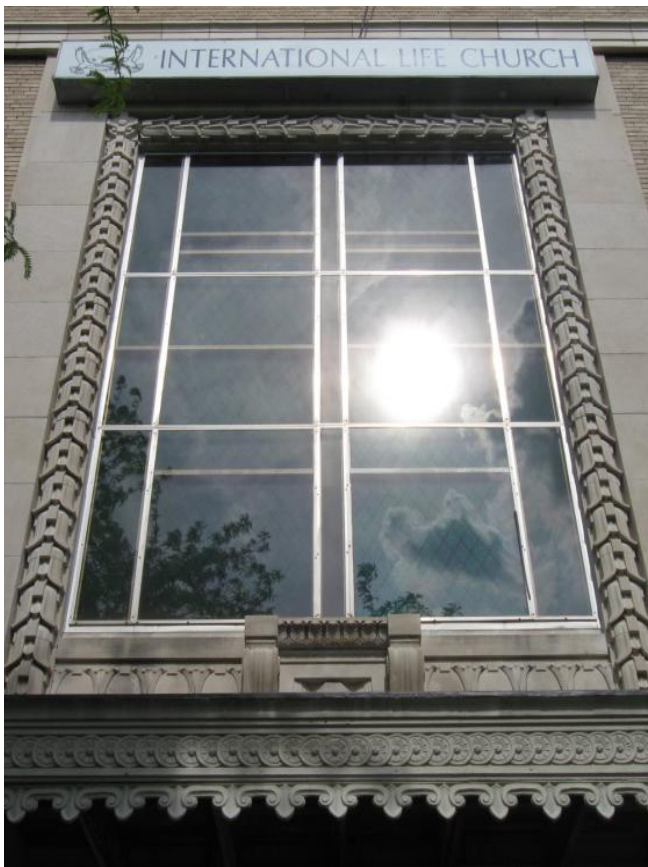
Photo 38. Second floor windows on west facade

A large aluminum framed window sits above the door at the west facade (See Photo 38). This window helps define the front entry and also provide natural light into the sanctuary. Like the other sanctuary windows, this window is aluminum and is not original to the building, as the light configuration in the 1925 clearly differs from the current configuration. This window also has a storm window on the exterior. This window is fair condition.

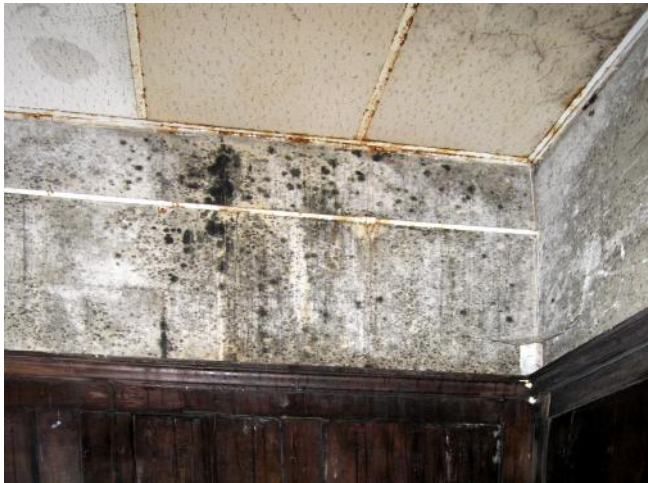
Photo 43. Mold growth on plaster at upper extent of lobby walls

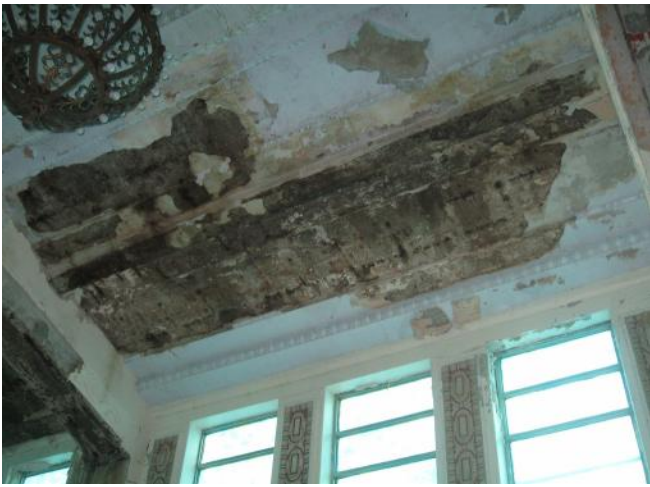
Photo 46. Detail of plaster damage at sanctuary ceiling

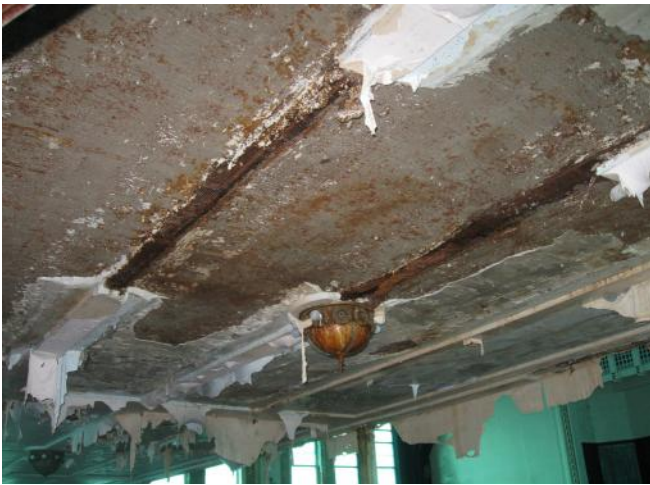
Photo 47. Detail of plaster damage at underside of balcony ceiling

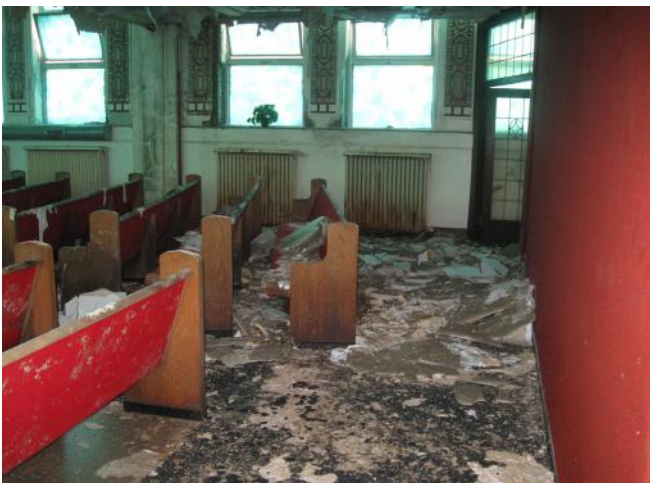
Photo 48. Damaged and mold covered pews

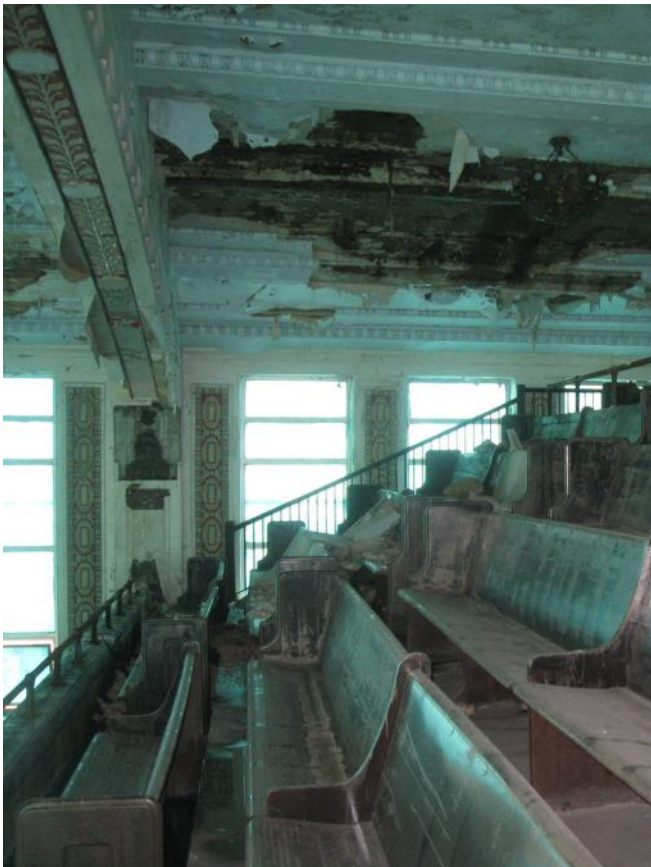
Photo 50. Water damaged pews at balcony
