BETH-EL TEMPLE FEASIBILITY STUDY DRAFT ISSUED 05.24.2013

PREPARED BY:
BROWNING DAY MULLINS DIERDORF ARCHITECTS

CONDITION ASSESSMENT.....35

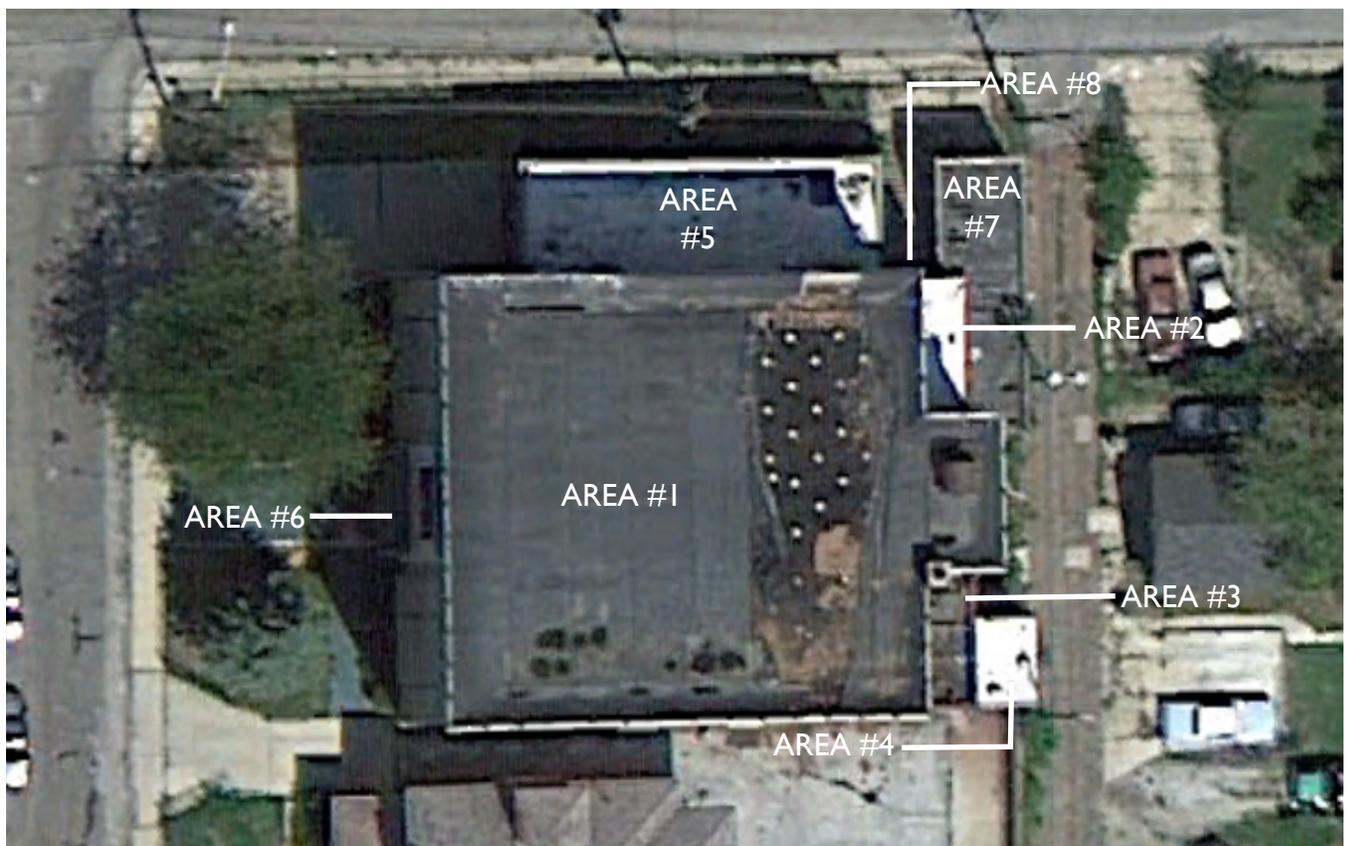
Area #1 is the main roof over the sanctuary and is the largest roof at 5480 SF. This roof is a single ply EPDM roof which was installed over a built up roof. The decking material is wood. The issue with this roof began with a seam failure and shrinkage at the perimeter of the roof causing it to tear away from the termination bar and exposing the underlying roofing and roof deck. This has occurred at both the north and south sides of the roof. At the time of Superior's report, they estimated that approximately 100 sf of roof area had been compromised. Although access to the roof was not available for the current study, based upon visual evidence of the plaster damage and water infiltration below in the sanctuary, as much as 3,000 sf of the 5,480 sf roof is compromised as of May 2013.

Photo 29. Satellite image of roof from Google Earth

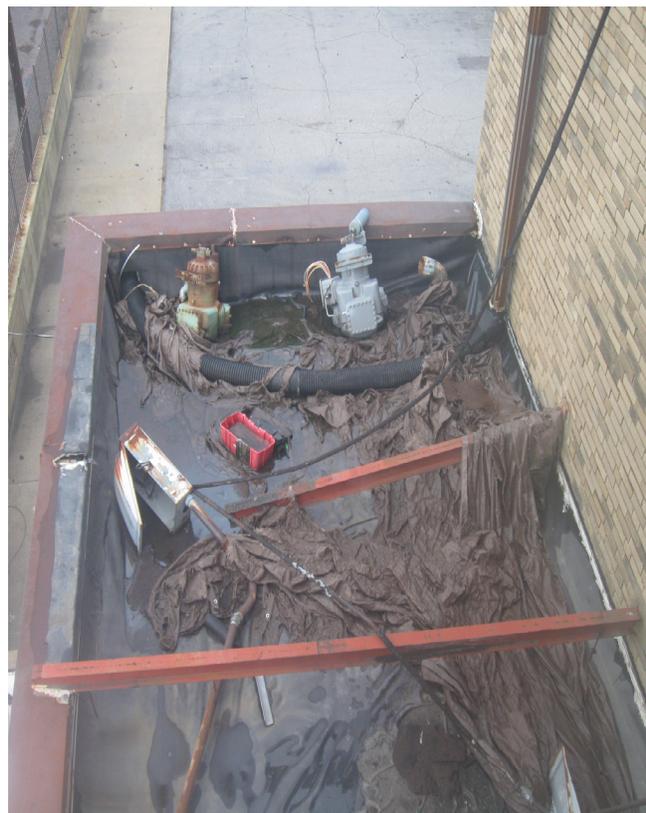
Area #3 roof covers the slightly lower roof at the southeast corner of the original portion of the building and covers 230 SF. This area has been reroofed with a single ply EPDM roof membrane and is in poor condition. This area has a significant amount of debris on it including a tarp, compressor, some metal scraps, etc. (See Photo 30). In addition to the debris, there are failed seams, membrane holes, roof penetrations and wall flashings.

Photo 30. Looking down on Area #3

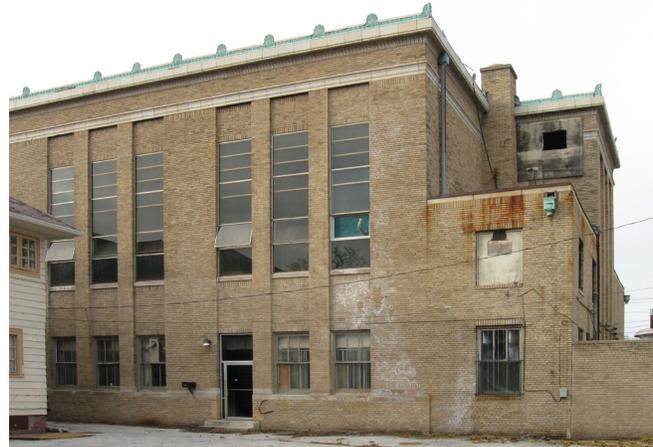
Because the roof has failed, water is making its way through the roof deck and into the interior of the building. This is saturating the walls. There is at least one location where efflorescence can be seen on the exterior brick (See Photo 31). Efflorescence is caused by water getting into the wall system and driving salts that are in the mortar to the surface of the brick. These salts form a powdery film at the locations where this is occurring.

At roof Area #2 and #3, a ferrous metal wall cap was used at the parapet wall. Over time, this metal has rusted leaving significant staining on the east facade brick. There are also a few areas on the north and south facades (See Photo 31) where rust stains are present. There is also additional staining caused by ferrous metal pipes.

Photo 31. Efflorescence, rust stains, and mortar deterioration at southeast corner

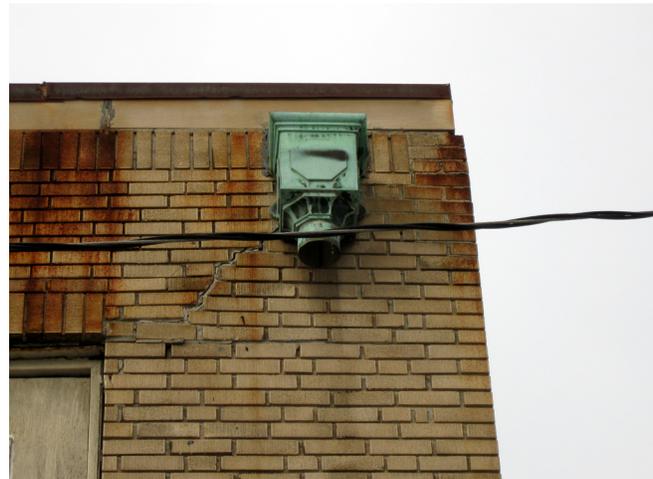
There are three (3) locations where downspouts are missing (See Photo 32). As water makes its way out

Photo 32. Rust staining, mortar deterioration, and missing downspout at southeast corner

of the conductor heads or gutters, it splashes down the face of the masonry. Over time, this becomes an issue as water eats away at the mortar. In the winter, ice can form and the freeze thaw cycle can do significant damage to both the brick and mortar.

The majority of the mortar deterioration at the brick is located near a downspout. It is estimated that approximately 20% of the entire surface area of the mortar is deteriorated to the point that it will need repointed.

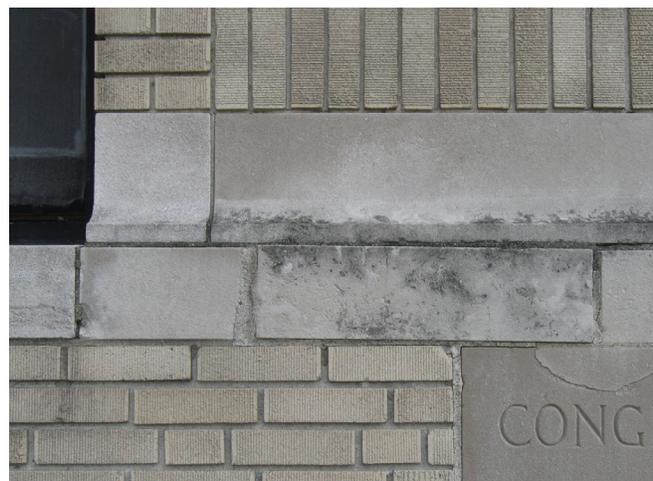
Photo 33. Mortar deterioration at limestone

The majority of the limestone on the building exhibits significant mortar deterioration. Likely, all of the limestone mortar joints will need repointed.

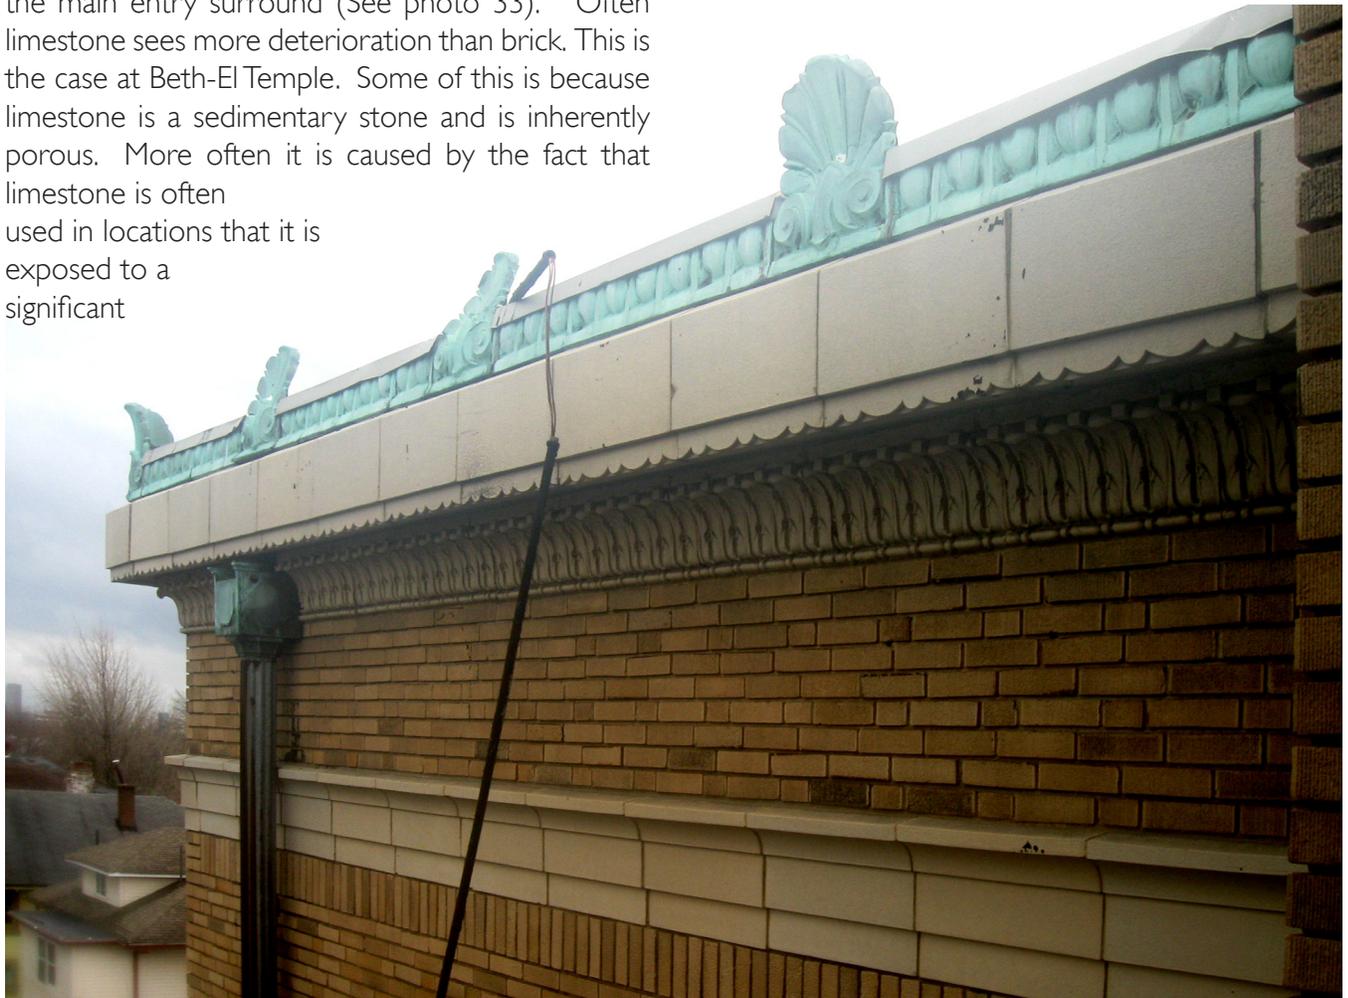
Terra cotta can have durability issues if it is not maintained. At least 15 of the acanthus leaf details at the cornice are missing. Several others are leaning and appear to be out of plane (See Photo 34). In total, 40 pieces of terra cotta were identified to be replaced.

Photo 34. Detail of terra cotta showing out of plane details

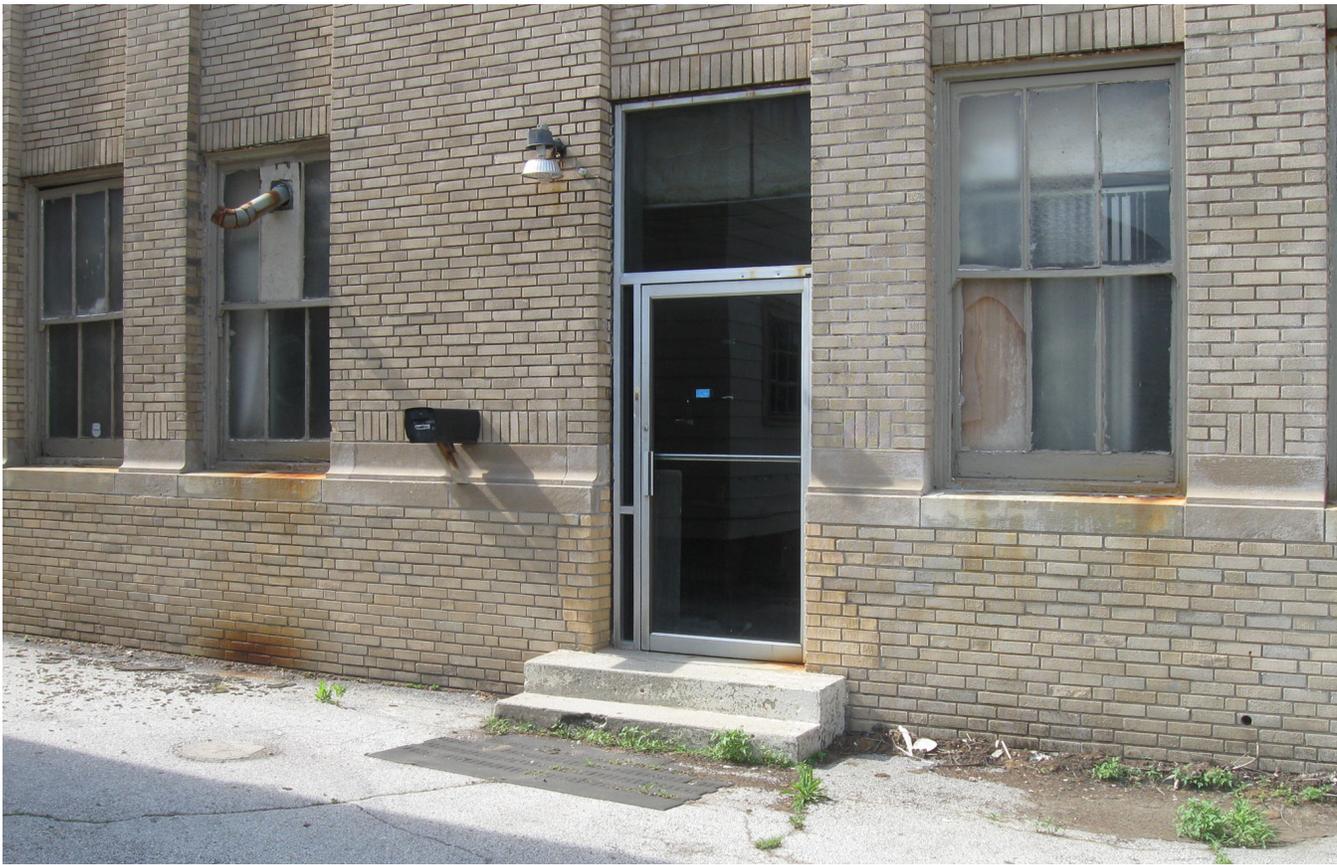
Photo 35. Typical first floor windows and south entrance door

The typical first floor windows on the north and south facades consists of a wood double hung unit with a three-over-three light configuration (See Photo 35 and 36). It measures 4'-4" x 7'-4". There are a total of eighteen (18) of this type of window. With the exception of one unit, they are all covered on the north elevation by the addition. From the interior, some of these units are still visible. The south elevation windows are all visible, although one of the units was converted into an entrance door. This is clear from looking at the brick at that location. The windows vary greatly in condition. Several of the windows on the south elevation are continually saturated from water infiltration that is making its way to the first floor from the leaks in the Area #1 roof above. These windows are exhibiting some rot and softening of the wood. Generally, all windows

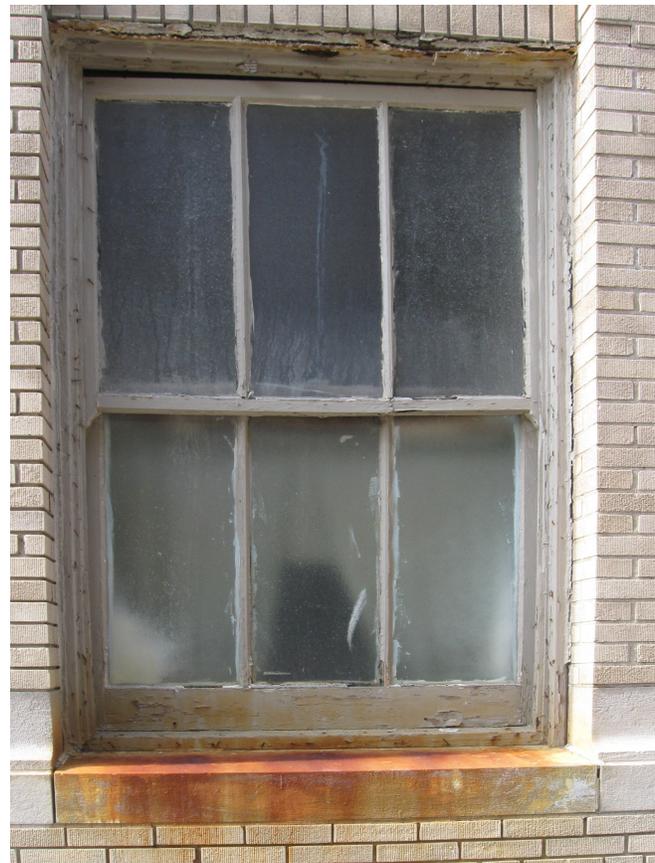
Photo 36. Typical first floor window

exhibit some deterioration due to water infiltration. Common issues among this window type are peeling paint, cracked window glazing, deteriorated glazing putty, and wood rot. Although these windows have some issues, it is not uncommon of windows of this age. They are original to the building and certainly can be restored.

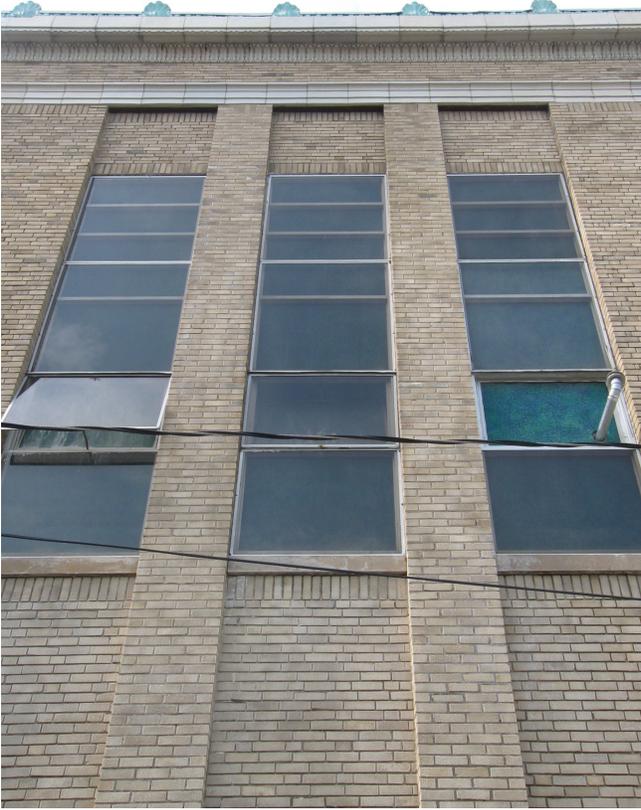
Photo 37. Second floor windows on south facade

There are eighteen (18) second floor sanctuary windows on the north and south facades (See Photo 37). These windows are aluminum framed windows divided into a six light configuration and measuring 4'4" wide by 16'-2" high. Some of the lights are operable. The glass consists of a translucent blue and white art glass. There is a storm window on the exterior. These windows are in poor condition. It is also clear that they are not original to the building, as a different light configuration is visible in the 1925 photograph.

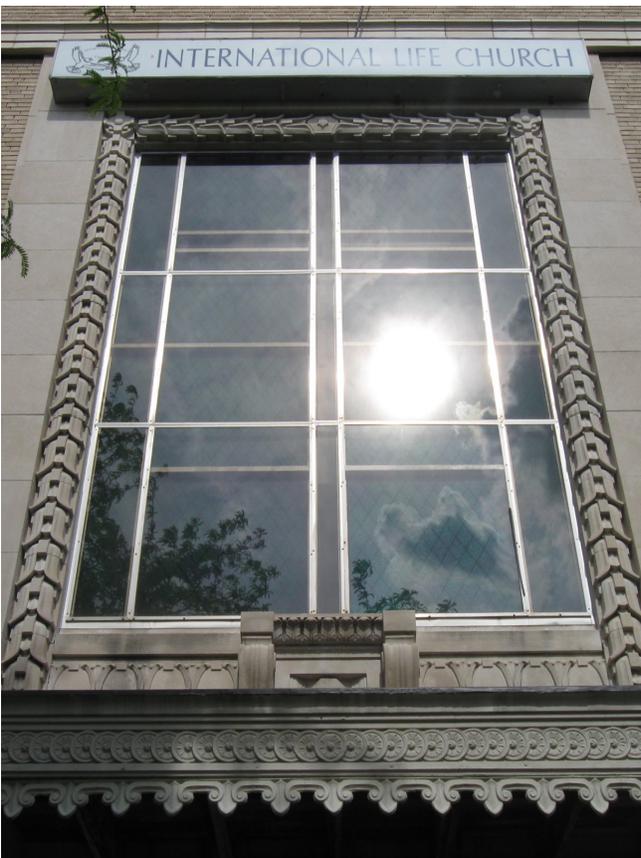
Photo 38. Second floor windows on west facade

A large aluminum framed window sits above the door at the west facade (See Photo 38). This window helps define the front entry and also provide natural light into the sanctuary. Like the other sanctuary windows, this window is aluminum and is not original to the building, as the light configuration in the 1925 clearly differs from the current configuration. This window also has a storm window on the exterior. This window is fair condition.

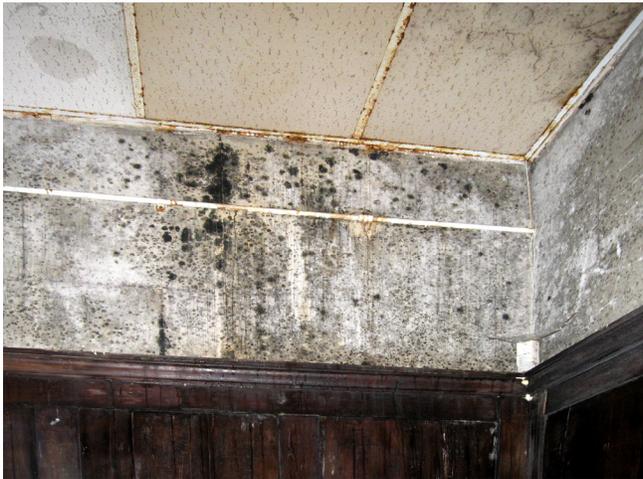
Photo 43. Mold growth on plaster at upper extent of lobby walls

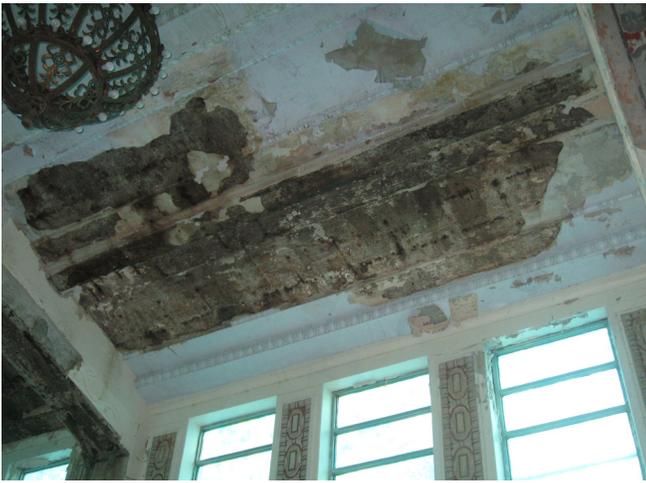
Photo 46. Detail of plaster damage at sanctuary ceiling

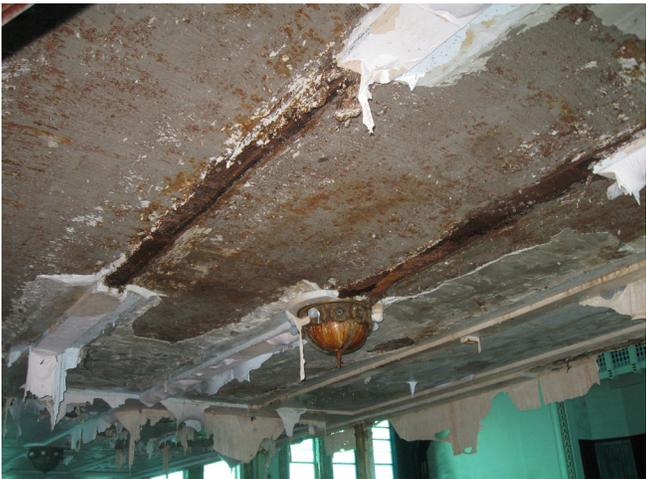
Photo 47. Detail of plaster damage at underside of balcony ceiling

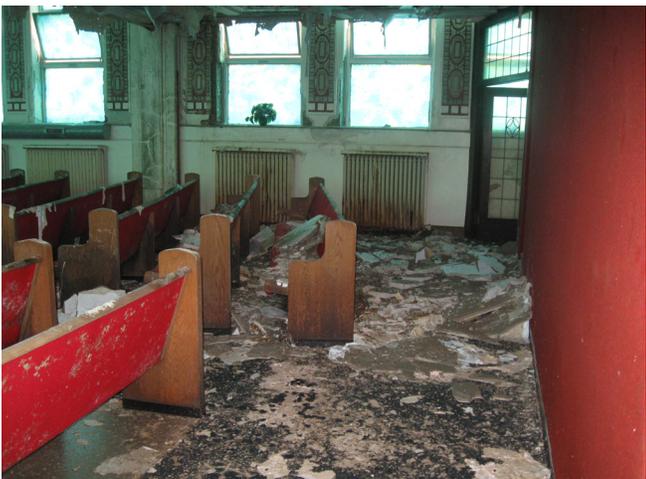
Photo 48. Damaged and mold covered pews

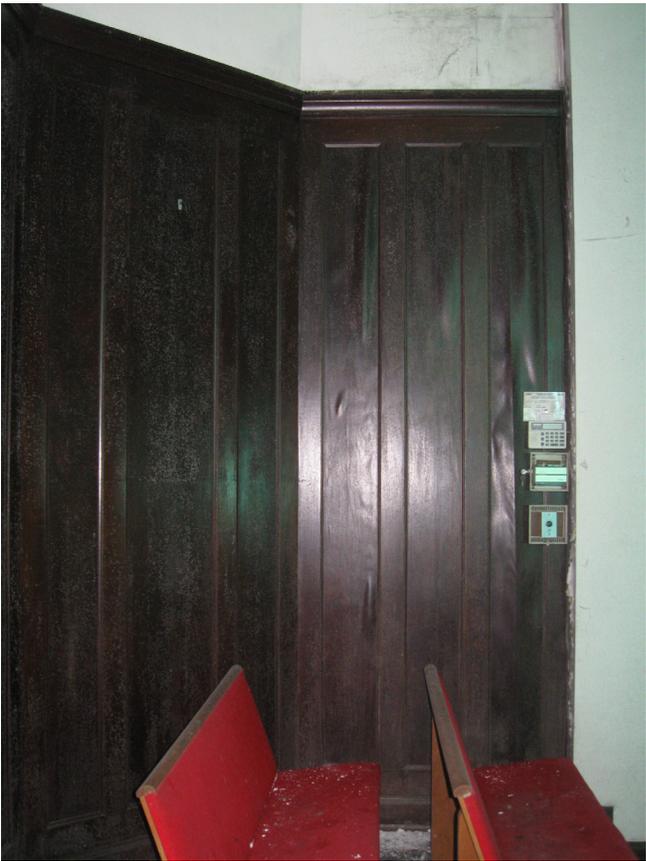
Photo 49. Warped veneer at wood paneling

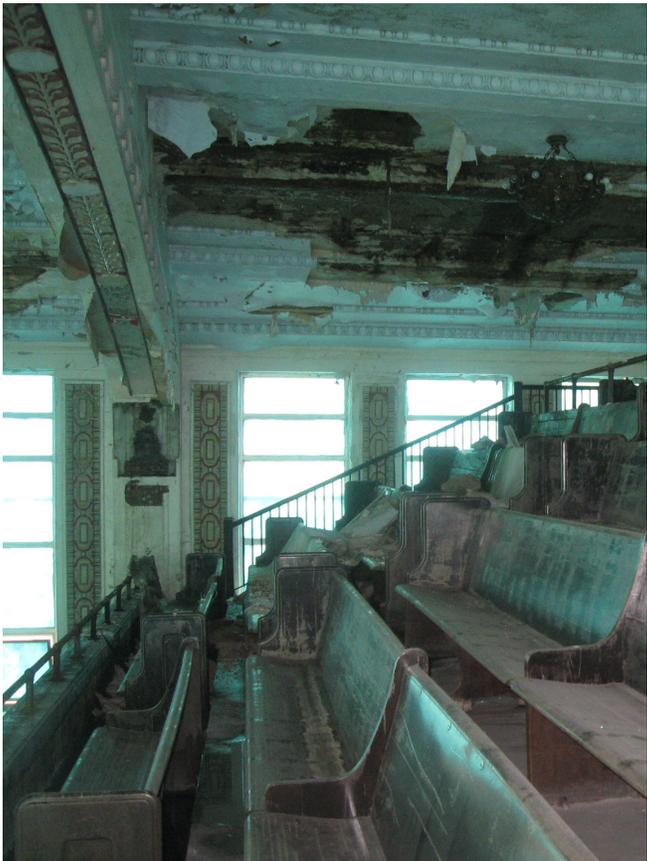
Photo 50. Water damaged pews at balcony
