BETH-EL TEMPLE FEASIBILITY STUDY

PREPARED BY:
BROWNING DAY MULLINS DIERDORF ARCHITECTS

CONDITION ASSESSMENT

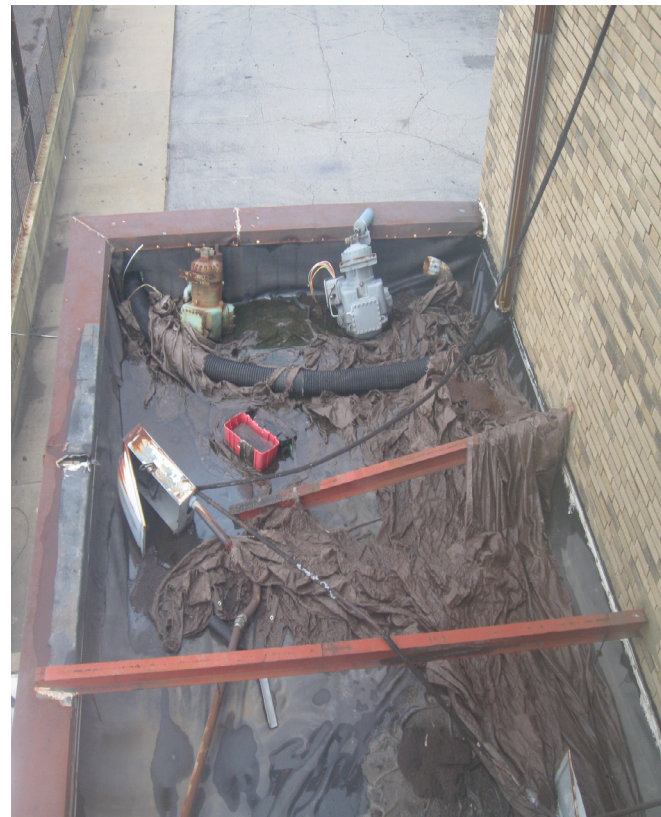
Photo 30. Looking down on Area #3

Area #3 roof covers the slightly lower roof at the southeast corner of the original portion of the building and covers 230 SF. This area has been reroofed with a single ply EPDM roof membrane and is in poor condition. This area has a significant amount of debris on it including a tarp, compressor, some metal scraps, etc. (See Photo 30). In addition to the debris, there are failed seams, membrane holes, roof penetrations and wall flashings.

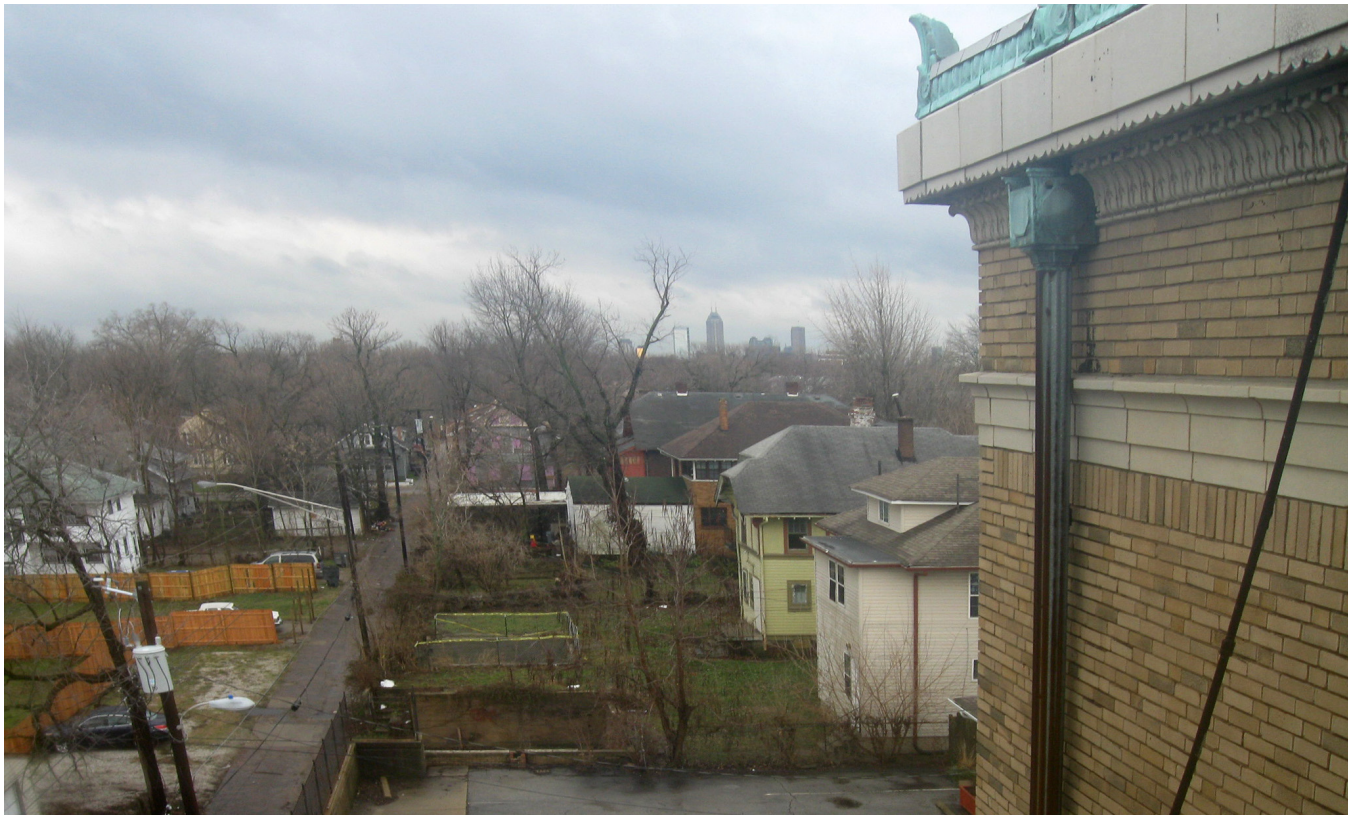
Photo 31. Detail of parapet, conductor head, and downspout

Area #2 is drained to a single scupper and conductor head on its east facade. The downspout is missing leading to water draining directly on the masonry. Once again, having a single way for water to exit the roof is not ideal and could lead to standing water on the roof if the scupper is not maintained and debris removed on a regular basis.

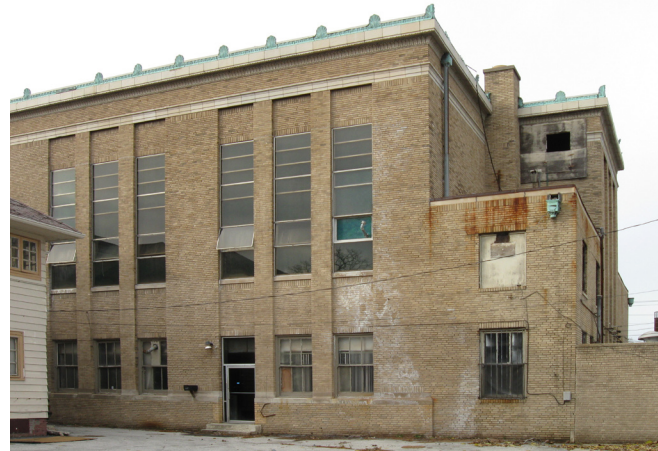
Because the roof has failed, water is making its way through the roof deck and into the interior of the building. This is saturating the walls. There is at least one location where efflorescence can be seen on the exterior brick (See Photo 31). Efflorescence is caused by water getting into the wall system and driving salts that are in the mortar to the surface of the brick. These salts form a powdery film at the locations where this is occurring.

At roof Area #2 and #3, a ferrous metal wall cap was used at the parapet wall. Over time, this metal has rusted leaving significant staining on the east facade brick. There are also a few areas on the north and south facades (See Photo 31) where rust stains are present. There is also additional staining caused by ferrous metal pipes.

Photo 31. Efflorescence, rust stains, and mortar deterioration at southeast corner

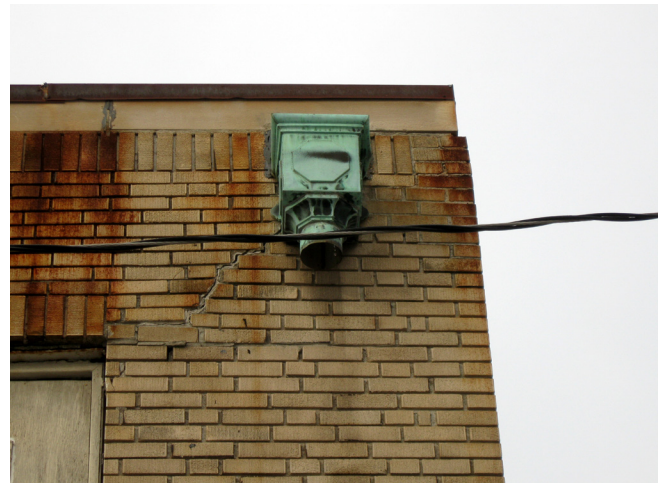
There are three (3) locations where downspouts are missing (See Photo 32). As water makes its way out

Photo 32. Rust staining, mortar deterioration, and missing downspout at southeast corner

of the conductor heads or gutters, it splashes down the face of the masonry. Over time, this becomes an issue as water eats away at the mortar. In the winter, ice can form and the freeze thaw cycle can do significant damage to both the brick and mortar.

The majority of the mortar deterioration at the brick is located near a downspout. It is estimated that approximately 20% of the entire surface area of the mortar is deteriorated to the point that it will need repointed.

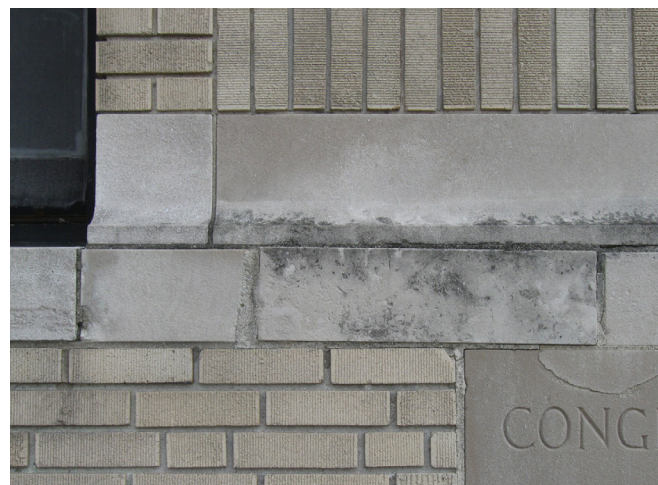
Photo 33. Mortar deterioration at limestone

The majority of the limestone on the building exhibits significant mortar deterioration. Likely, all of the limestone mortar joints will need repointed.

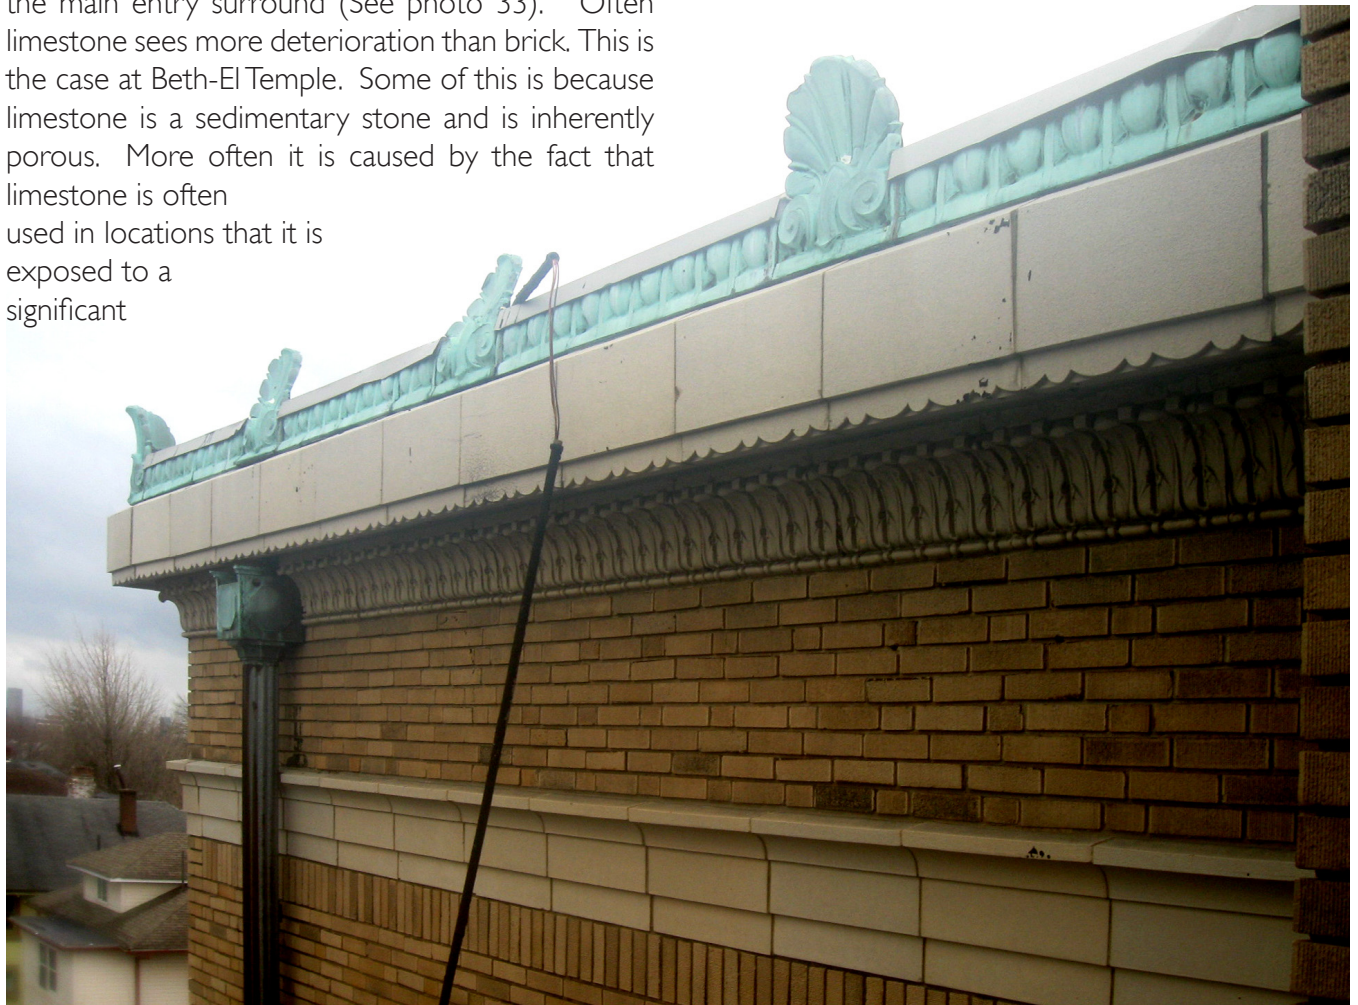
Terra cotta can have durability issues if it is not maintained. At least 15 of the acanthus leaf details at the cornice are missing. Several others are leaning and appear to be out of plane (See Photo 34). In total, 40 pieces of terra cotta were identified to be replaced.

Photo 34. Detail of terra cotta showing out of plane details

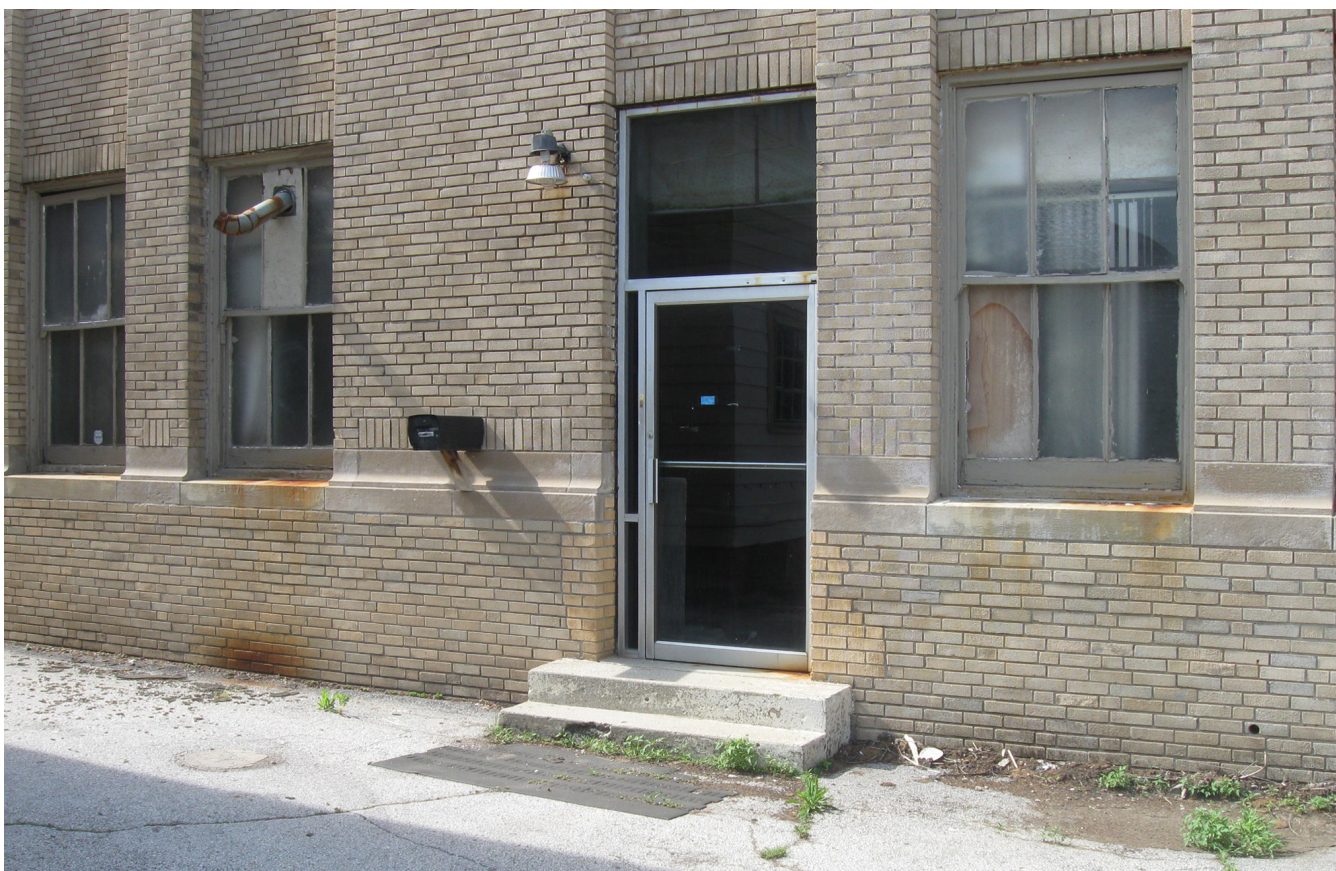
Photo 35. Typical first floor windows and south entrance door

The typical first floor windows on the north and south facades consist of a wood double hung unit with a three-over-three light configuration (See Photo 35 and 36). It measures 4'-4" x 7'-4". There are a total of eighteen (18) of this type of window. With the exception of two units, they are all covered on the north elevation by the addition. From the interior, some these units are still visible. The south elevation windows are all visible, although one of the units was converted into an entrance door. This is clear from looking at the brick at that location. The windows vary greatly in condition. Several of the windows on the south elevation are continually saturated from water infiltration that is making its way to the first floor from the leaks in the Area #1 roof above. These windows are exhibiting some rot and softening of the wood. Generally, all windows

exhibit some deterioration due to water infiltration. Common issues among this window type are peeling paint, cracked window glazing, deteriorated glazing putty, and wood rot. Although these windows have some issues, it is not uncommon of windows of this age. They are original to the building and certainly can be restored.

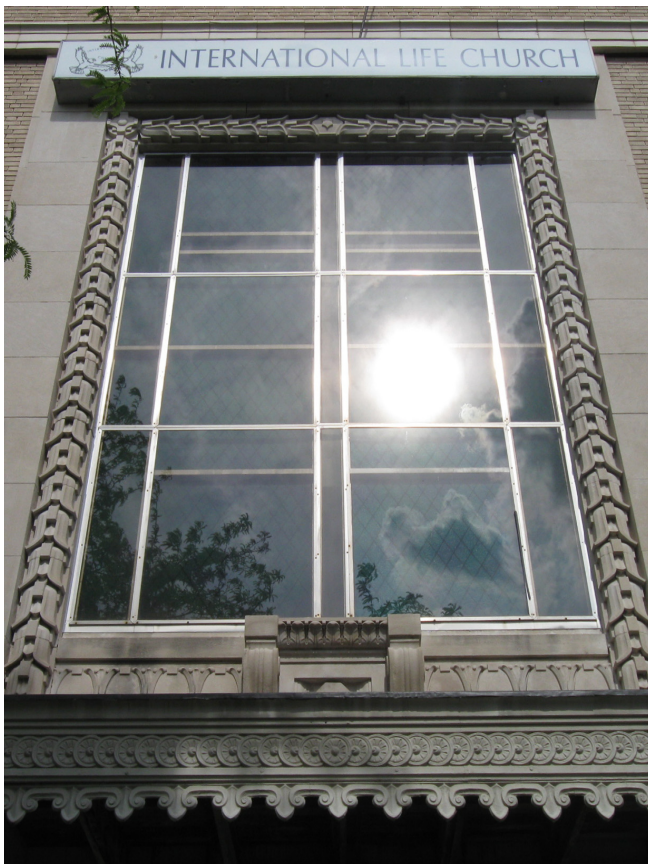
Photo 38. Second floor windows on west facade

A large aluminum framed window sits above the door at the west facade (See Photo 38). This window helps define the front entry and also provide natural light into the sanctuary. Like the other sanctuary windows, this window is aluminum and is not original to the building, as the light configuration in the 1925 clearly differs from the current configuration. This window also has a storm window on the exterior. This window is fair condition.

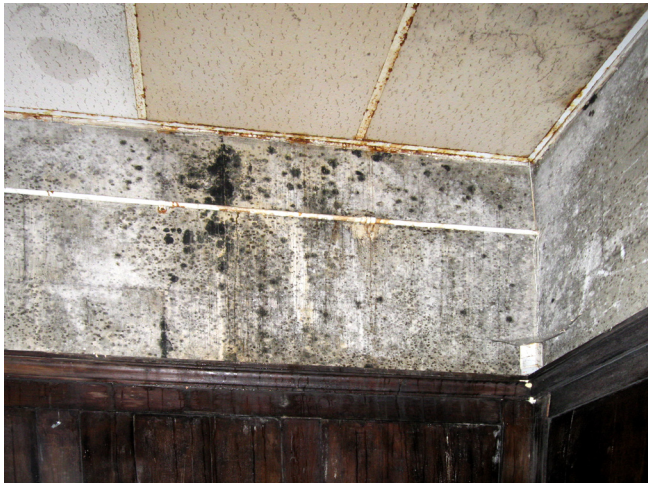
Photo 43. Mold growth on plaster at upper extent of lobby walls

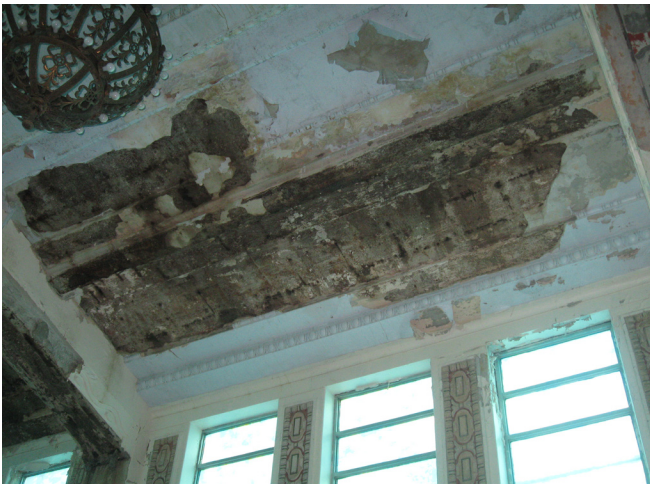
Photo 46. Detail of plaster damage at sanctuary ceiling

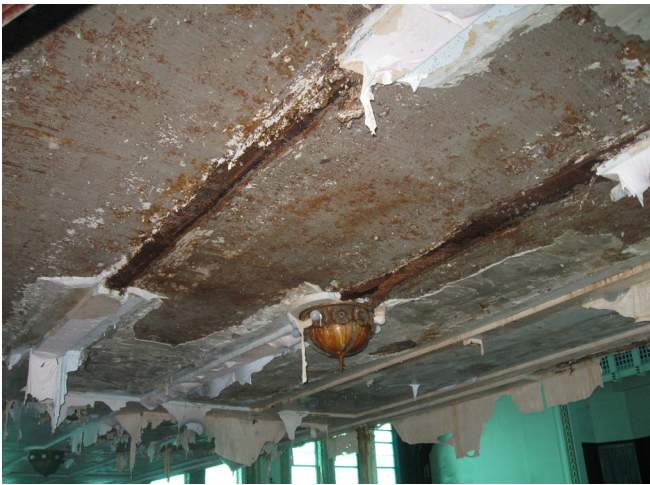
Photo 47. Detail of plaster damage at underside of balcony ceiling

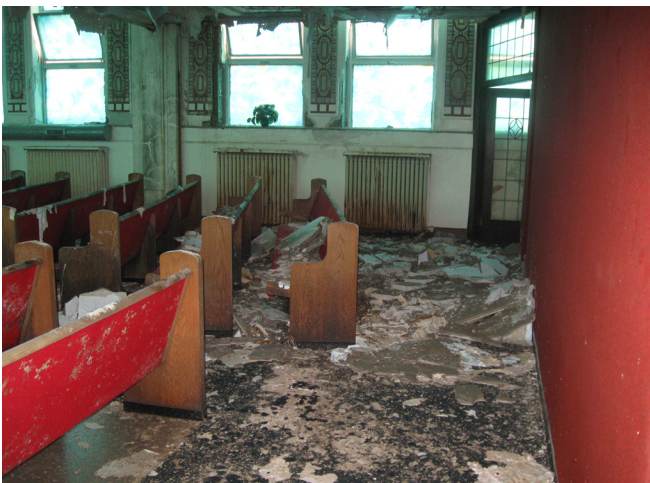
Photo 48. Damaged and mold covered pews

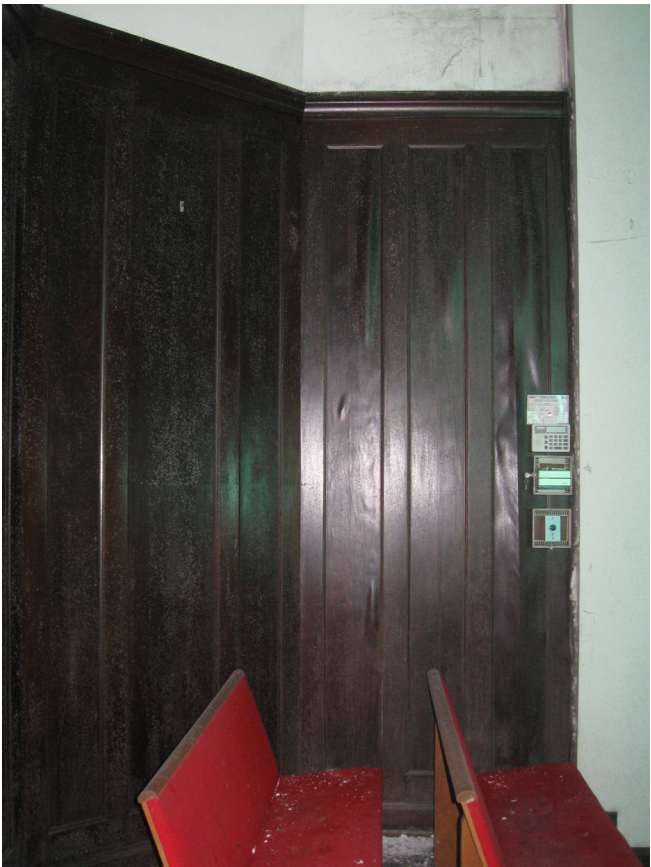
All of the wood paneling is saturated with water and the veneer is warped and delaminating from the substrate (See Photo 42). Very little of the wood paneling can be salvaged. The plaster above the paneling is in fair condition and can be salvaged, but has an enormous amount of mold growth on it (See Photo 43 and 44). The (4) historic wood doors in the lobby are in poor condition, but can be restored (See Photo 45). The acoustical ceiling tile ceiling is a non-historic feature and in poor condition. Portions of the ceiling tile, grid, and historic plaster ceiling above have fallen to the floor. (See Photo 44) The ceramic floor tile is in fair condition. The two stairs in the lobby and their decorative railing are in fair condition and can be reused.

Photo 49. Warped veneer at wood paneling

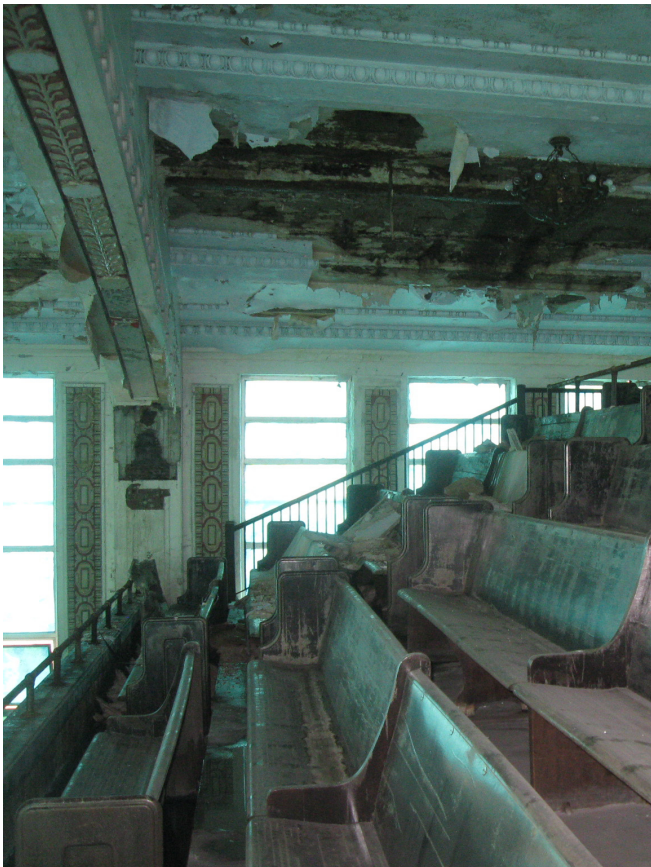
Photo 50. Water damaged pews at balcony
