BETH-EL TEMPLE FEASIBILITY STUDY DRAFT ISSUED 05.24.2013

PREPARED BY:
BROWNING DAY MULLINS DIERDORF ARCHITECTS

CONDITION ASSESSMENT.....35

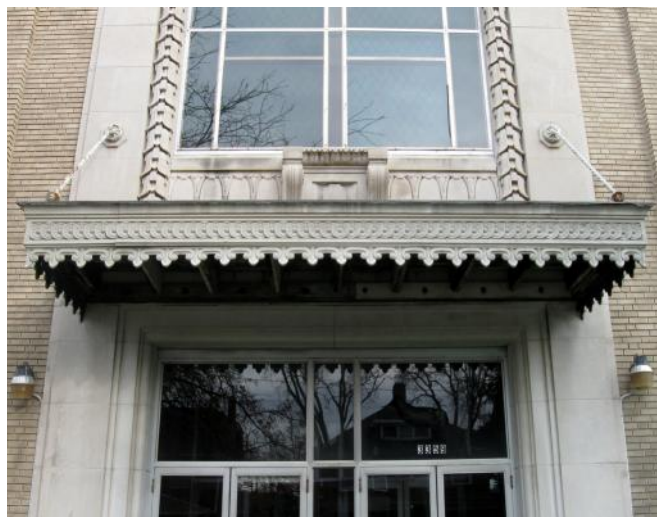
Both canopies consists of a cast iron fascia with steel or cast iron tension rods connected back to the building. Within the cast iron fascia, is wood 2x framing and a wood deck. The roof sits on top of the wood deck. Both the north (See Photo 40) and west (See Photo 41) canopies are missing their original ceilings, so the wood framing is visible and appears to be in good condition. The cast iron is generally in good condition, although the north canopy has some surface rust. Both paint systems are failing.

Photo 41. West canopy

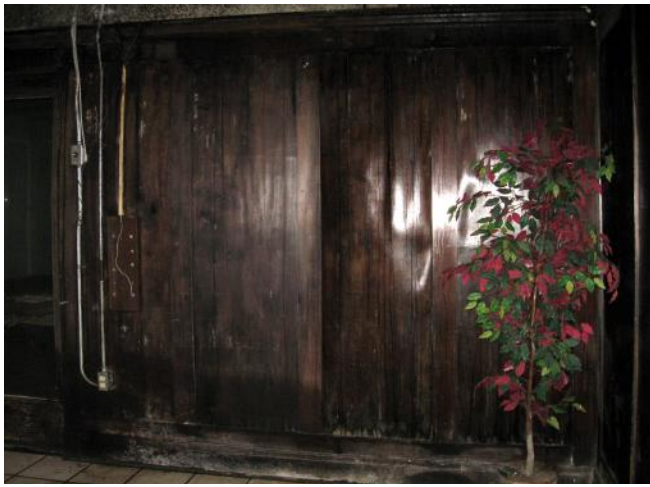
Photo 42. Warped veneer at lobby paneling

All of the wood paneling is saturated with water and the veneer is warped and delaminating from the substrate (See Photo 42). Very little of the wood paneling can be salvaged. The plaster above the paneling is in fair condition and can be salvaged, but has an enormous amount of mold growth on it (See Photo 43 and 44). The (4) historic wood doors in the lobby are in poor condition, but can be restored (See Photo 45). The acoustical ceiling tile ceiling is a non-historic feature and in poor condition. Portions of the ceiling tile, grid, and historic plaster ceiling above have fallen to the floor. (See Photo 44) The ceramic floor tile is in fair condition.

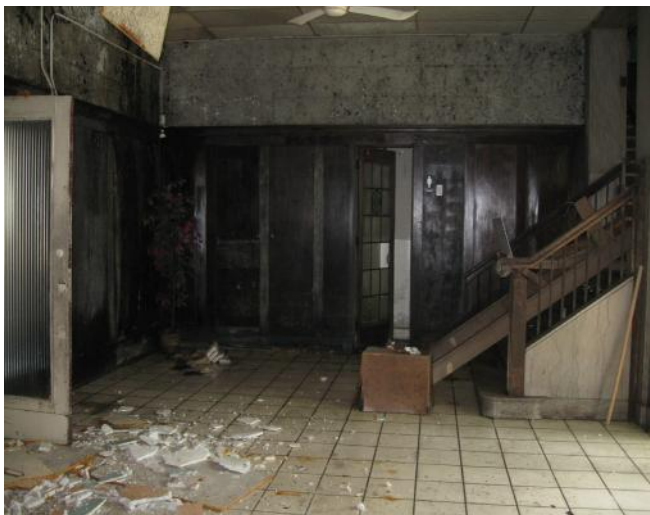
Photo 44. Looking south in lobby
