# BETH-EL TEMPLE FEASIBILITY STUDY DRAFT ISSUED 05.24.2013

PREPARED BY:  
BROWNING DAY MULLINS DIERDORF ARCHITECTS

# EXECUTIVE SUMMARY

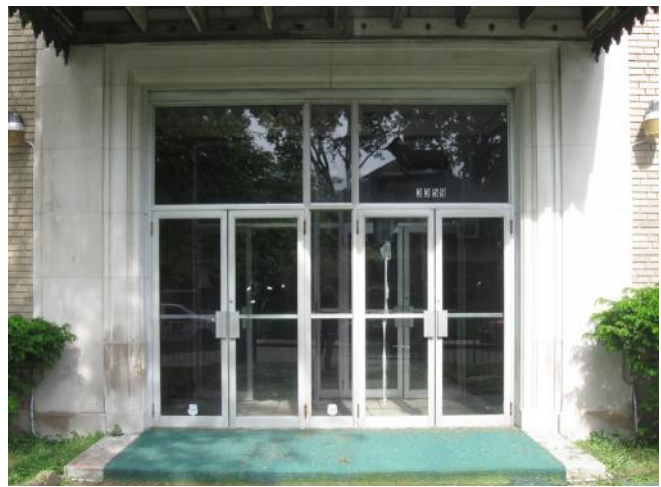
Photo 39. West entry doors

All of the exterior doors are replacement doors and are not original to the building. At both the west entry (See Photo 39) and south entry (See Photo 35), the door systems consists of a clear anodized aluminum frames and doors. Both of these door systems are dated and are not original to the building.

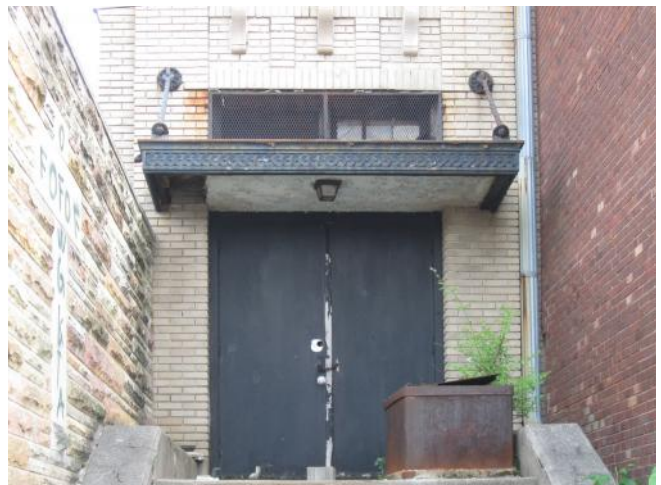
Photo 40. North entry doors and canopy

The north entry (See Photo 40) consists of a pair of slab (no windows) doors. It appears from the 1925 photograph that a wood or metal framed pair of glass doors were originally installed at this location.

Both canopies consists of a cast iron fascia with steel or cast iron tension rods connected back to the building. Within the cast iron fascia, is wood 2x framing and a wood deck. The roof sits on top of the wood deck. Both the north (See Photo 40) and west (See Photo 41) canopies are missing their original ceilings, so the wood framing is visible and appears to be in good condition. The cast iron is generally in good condition, although the north canopy has some surface rust. Both paint systems are failing.

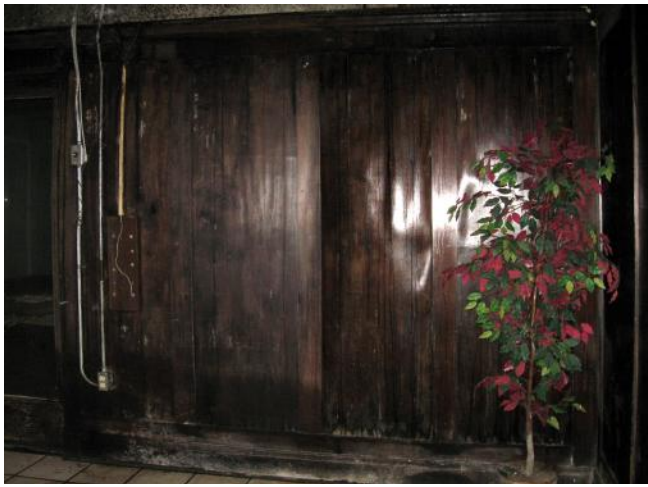
Photo 42. Warped veneer at lobby paneling

All of the wood paneling is saturated with water and the veneer is warped and delaminating from the substrate (See Photo 42). Very little of the wood paneling can be salvaged. The plaster above the paneling is in fair condition and can be salvaged, but has an enormous amount of mold growth on it (See Photo 43 and 44). The (4) historic wood doors in the lobby are in poor condition, but can be restored (See Photo 45). The acoustical ceiling tile ceiling is a non-historic feature and in poor condition. Portions of the ceiling tile, grid, and historic plaster ceiling above have fallen to the floor. (See Photo 44) The ceramic floor tile is in fair condition.
