BETH-EL TEMPLE FEASIBILITY STUDY DRAFT ISSUED 05.24.2013

PREPARED BY:
BROWNING DAY MULLINS DIERDORF ARCHITECTS

CONDITION ASSESSMENT.....35

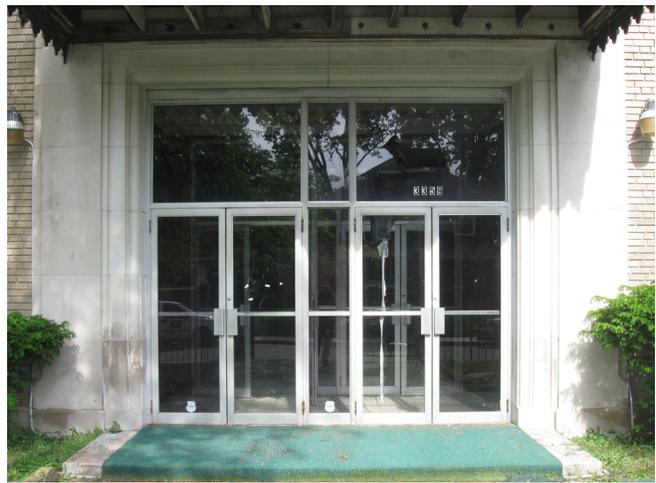
All of the exterior doors are replacement doors and are not original to the building. At both the west entry (See Photo 39) and south entry (See Photo 35), the door systems consists of a clear anodized aluminum frames and doors. Both of these door systems are dated and are not original to the building.

Photo 39. West entry doors

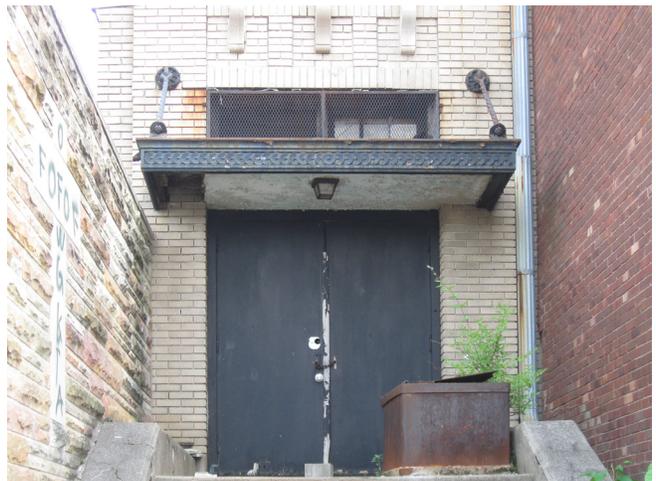
The north entry (See Photo 40) consists of a pair of slab (no windows) doors. It appears from the 1925 photograph that a wood or metal framed pair of glass doors were originally installed at this location.

Both canopies consists of a cast iron fascia with steel or cast iron tension rods connected back to the building. Within the cast iron fascia, is wood 2x framing and a wood deck. The roof sits on top of the wood deck. Both the north (See Photo 40) and west (See Photo 41) canopies are missing their original ceilings, so the wood framing is visible and appears to be in good condition. The cast iron is generally in good condition, although the north canopy has some surface rust. Both paint systems are failing.

Photo 40. North entry doors and canopy

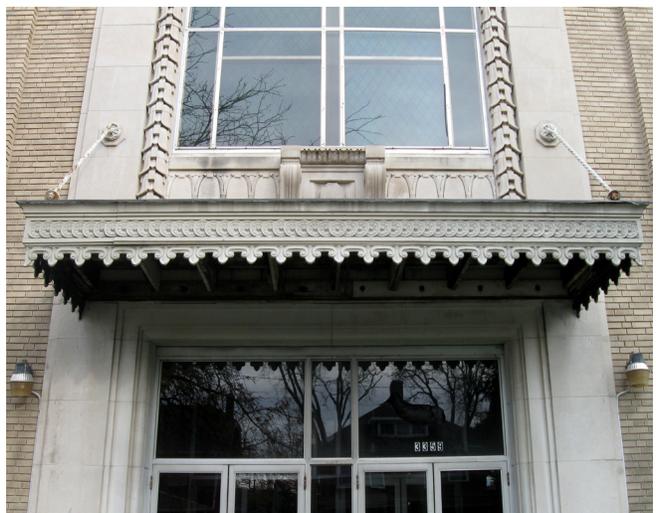
Photo 41. West canopy

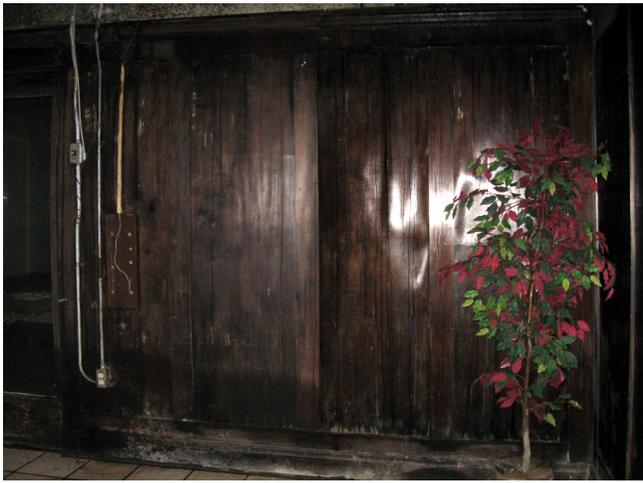
Photo 42. Warped veneer at lobby paneling

All of the wood paneling is saturated with water and the veneer is warped and delaminating from the substrate (See Photo 42). Very little of the wood paneling can be salvaged. The plaster above the paneling is in fair condition and can be salvaged, but has an enormous amount of mold growth on it (See Photo 43 and 44). The (4) historic wood doors in the lobby are in poor condition, but can be restored (See Photo 45). The acoustical ceiling tile ceiling is a non-historic feature and in poor condition. Portions of the ceiling tile, grid, and historic plaster ceiling above have fallen to the floor. (See Photo 44) The ceramic floor tile is in fair condition.

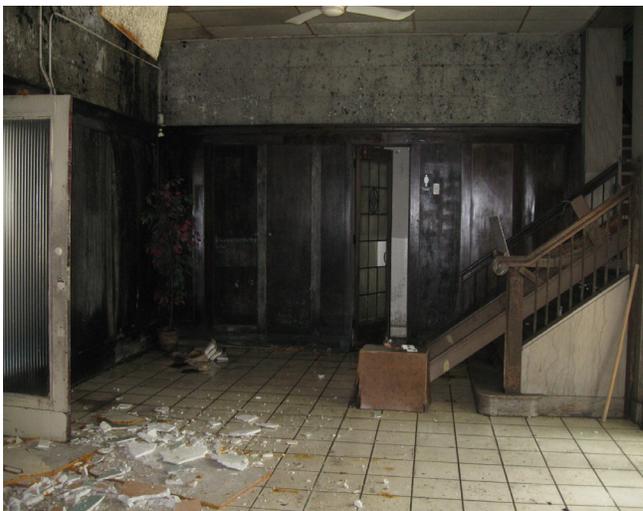
Photo 44. Looking south in lobby
