BETH-EL TEMPLE FEASIBILITY STUDY

PREPARED BY:
BROWNING DAY MULLINS DIERDORF ARCHITECTS

CONDITION ASSESSMENT

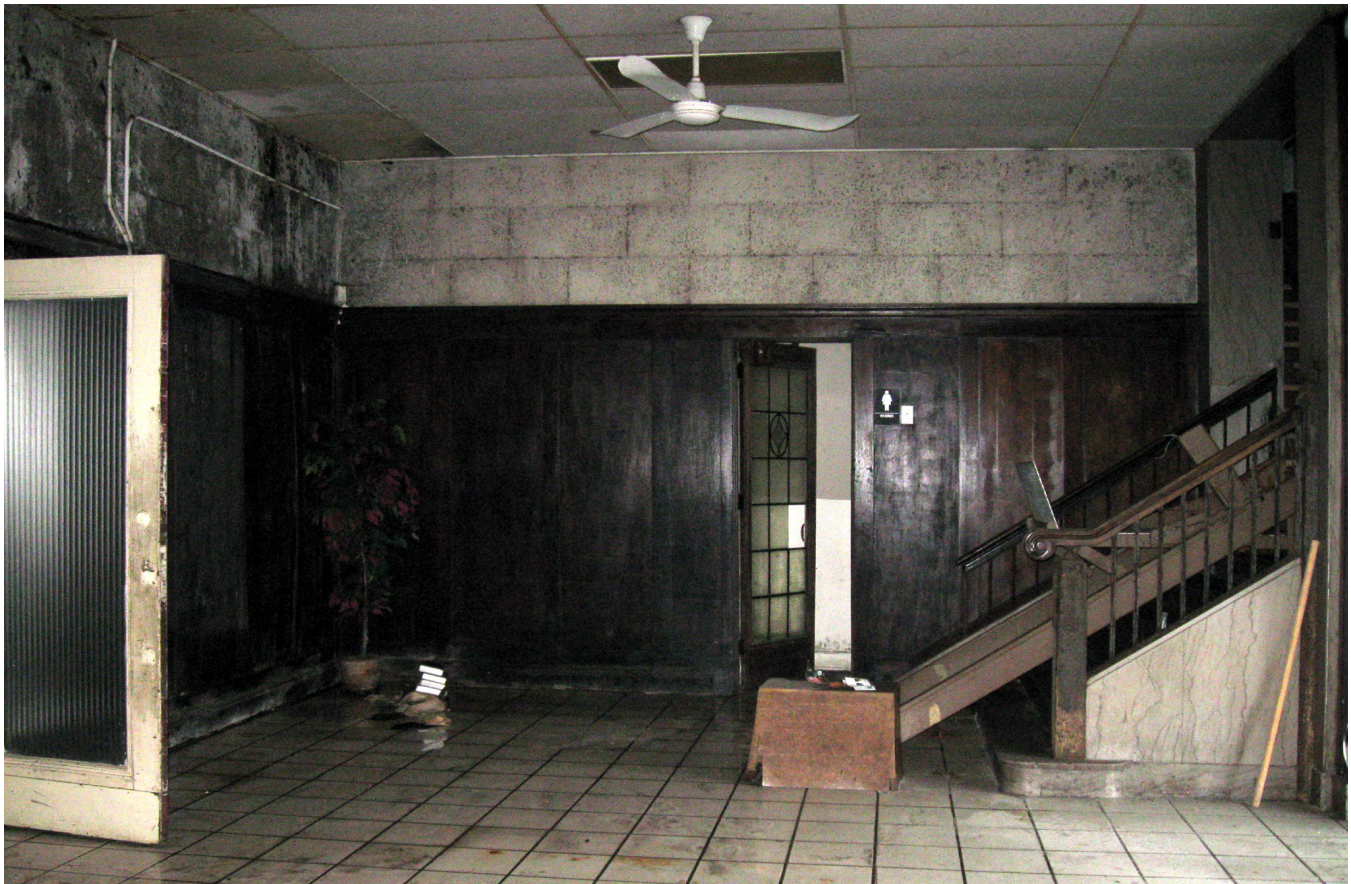
Photo 14. Lobby looking south

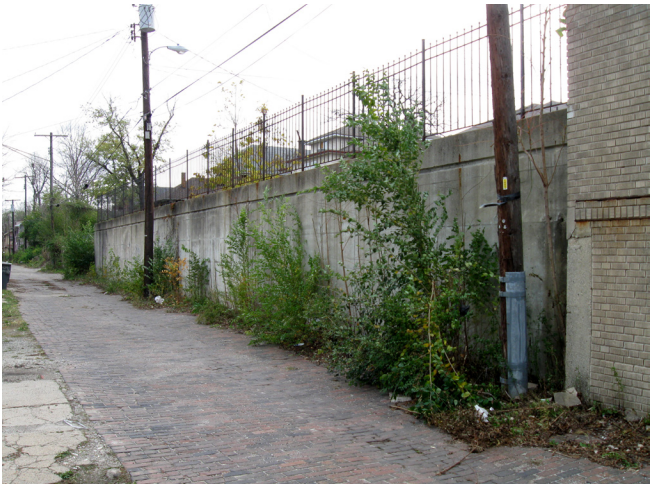
Photo 26. Concrete retaining wall at south parcel

to the west of the east property line. To the south of the east facade is a concrete retaining wall (See Photo 26) which retains earth in order to allow the parcel to its west to be at approximately the same elevation as Ruckle Street. This allows vehicular traffic from Ruckle Street by way of an asphalt driveway on the south extent of the building, to the parking area to the south of the building.

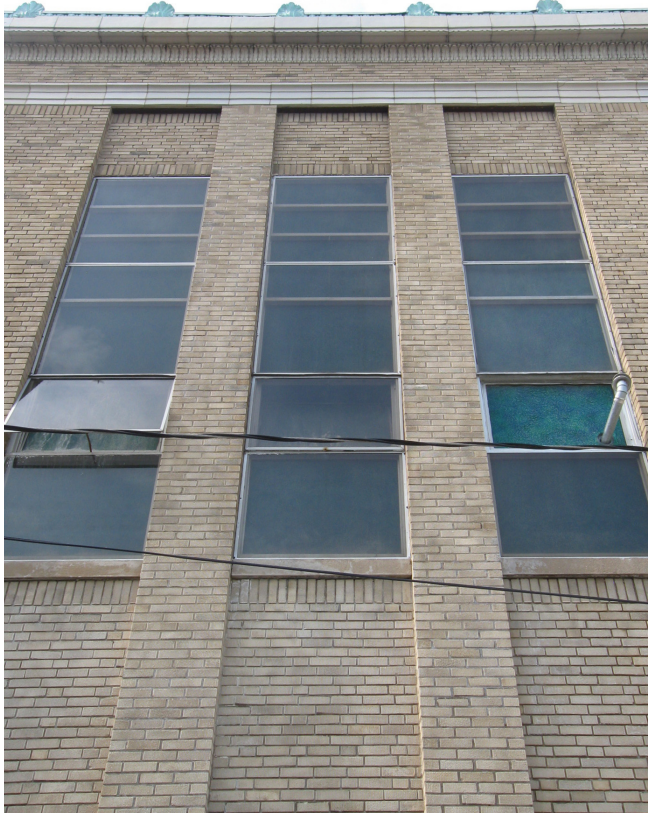
Photo 37. Second floor windows on south facade

There are eighteen (18) second floor sanctuary windows on the north and south facades (See Photo 37). These windows are aluminum framed windows divided into a seven (7) light configuration and measuring 4'4" wide by 16'-2" high. Some of the lights are operable. The glass consists of a translucent blue and white art glass. There is a storm window on the exterior. These windows are in poor condition. It is also clear that they are not original to the building, as a different light configuration is visible in the 1925 photograph.

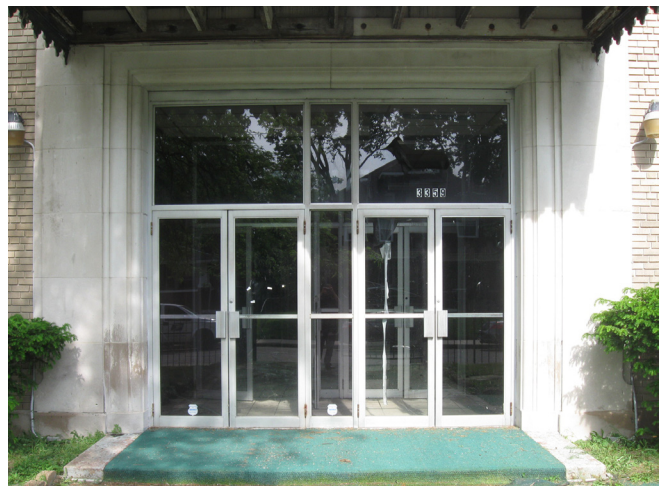
All of the exterior doors are replacement doors and are not original to the building. At both the west entry (See Photo 39) and south entry (See Photo 35), the door systems consists of a clear anodized aluminum frames and doors. Both of these door systems are dated and are not original to the building.

Photo 39. West entry doors

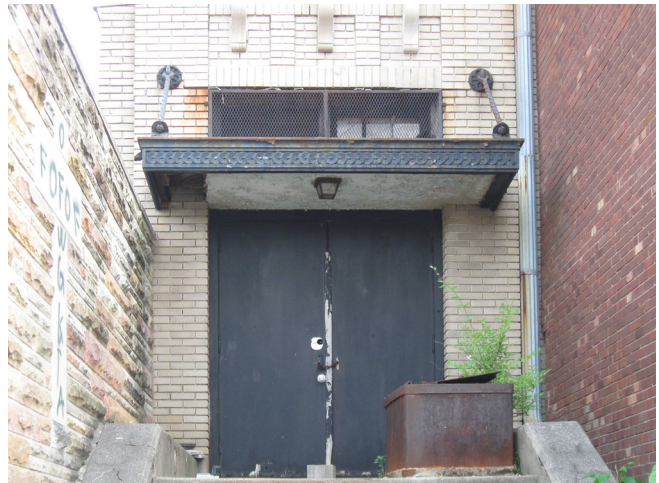
The north entry (See Photo 40) consists of a pair of slab (no windows) doors. It appears from the 1925 photograph that a wood or metal framed pair of glass doors were originally installed at this location.

Both canopies consists of a cast iron fascia with steel or cast iron tension rods connected back to the building. Within the cast iron fascia is wood 2x framing and a wood deck. The roof sits on top of the wood deck. Both the north (See Photo 40) and west (See Photo 41) canopies are missing their original ceilings, so the wood framing is visible and appears to be in good condition. The cast iron is generally in good condition, although the north canopy has some surface rust. Both paint systems are failing.

Photo 40. North entry doors and canopy

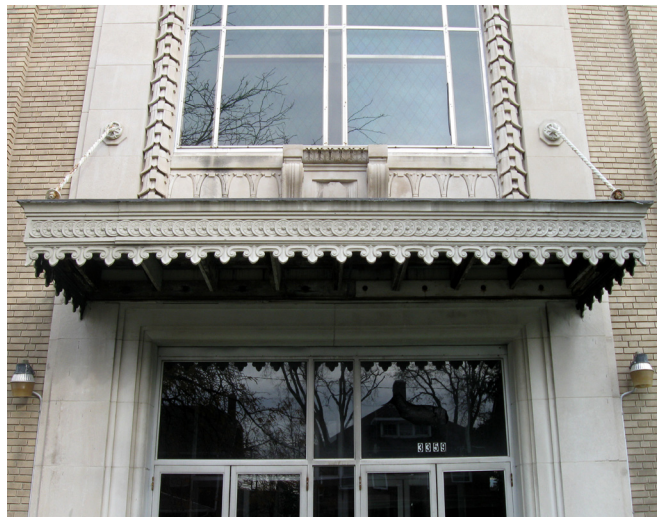
Photo 41. West canopy

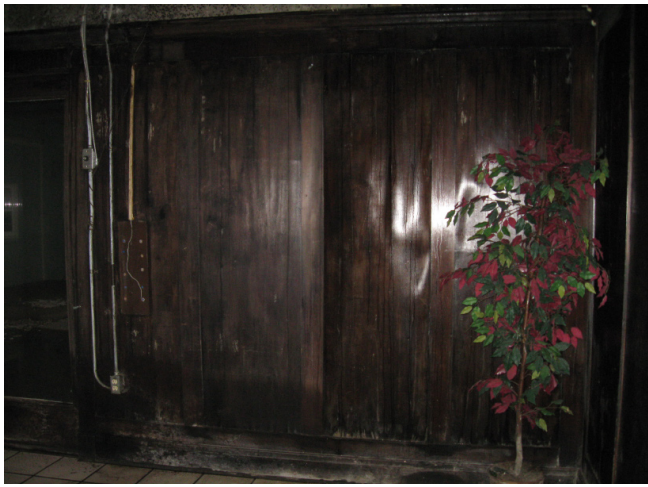
Photo 42. Warped veneer at lobby paneling

All of the wood paneling is saturated with water and the veneer is warped and delaminating from the substrate (See Photo 42). Very little of the wood paneling can be salvaged. The plaster above the paneling is in fair condition and can be salvaged, but has an enormous amount of mold growth on it (See Photo 43 and 44). The (4) historic wood doors in the lobby are in poor condition, but can be restored (See Photo 45). The acoustical ceiling tile ceiling is a non-historic feature and in poor condition. Portions of the ceiling tile, grid, and historic plaster ceiling above have fallen to the floor. (See Photo 44) The ceramic floor tile is in fair condition. The two stairs in the lobby and their decorative railing are in fair condition and can be reused.

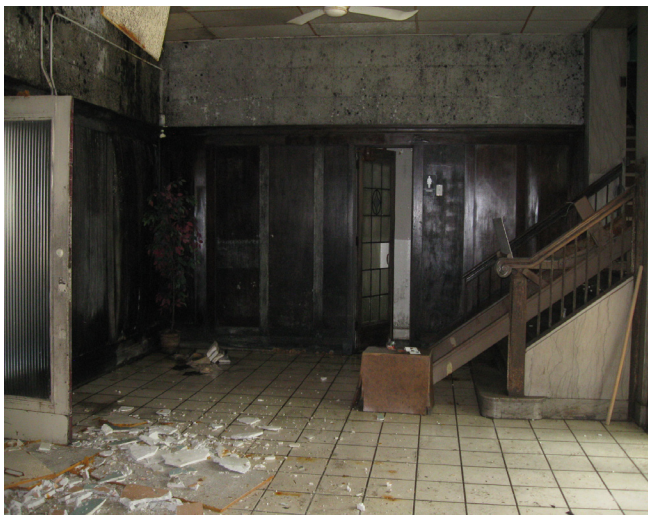
Photo 44. Looking south in lobby
